# **SAFETY OF LITHIUM NICKEL COBALT ALUMINUM OXIDE BATTERY PACKS IN TRANSIT BUS APPLICATIONS**

February 2016

## ABSTRACT

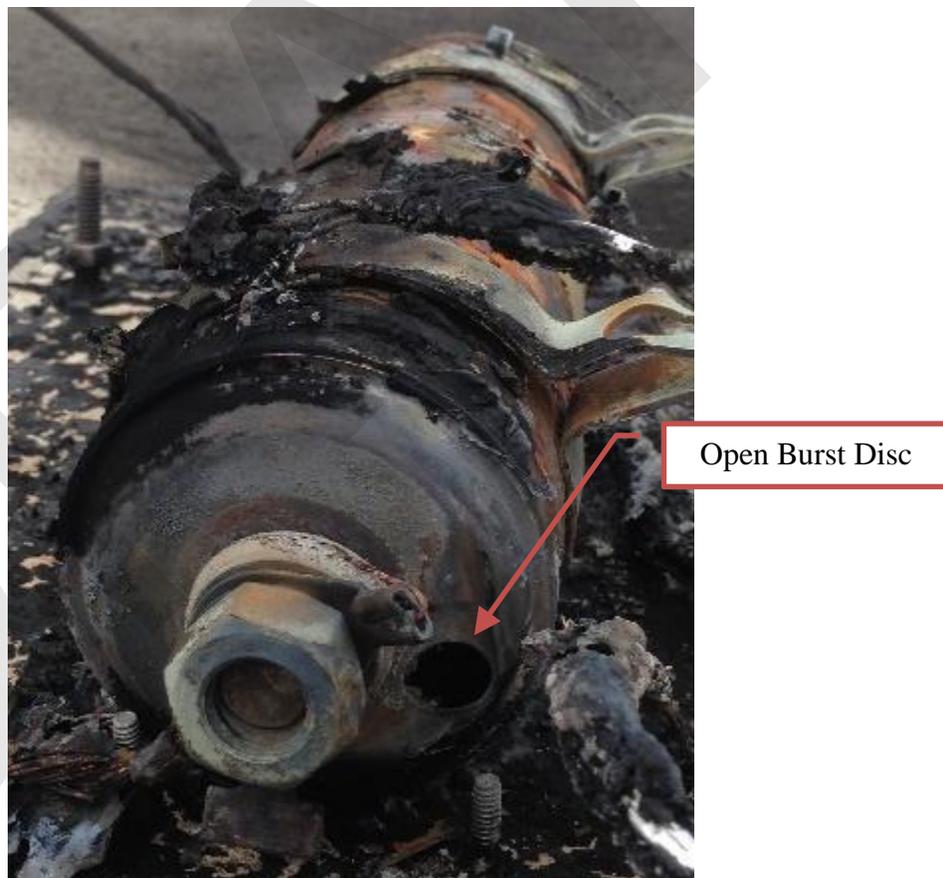
Figure 1. **Cell After Venting Event**

In general, whenever a charged Li-ion cell is exposed to temperatures above 60°C, there is a risk of initiating a strong exothermic reaction within the cell. The heat generated by these reactions will result in a rise in the cell temperature, which in turn activates heat generation amplitude or additional exothermic reactions that build up pressure in the cell. The cells used in this research are equipped with a safety/pressure burst disc at each terminal side rated at 144-200 psi at room temperature. Figure 1 shows a cell that was overcharged until its burst discs were opened and the cell vented.

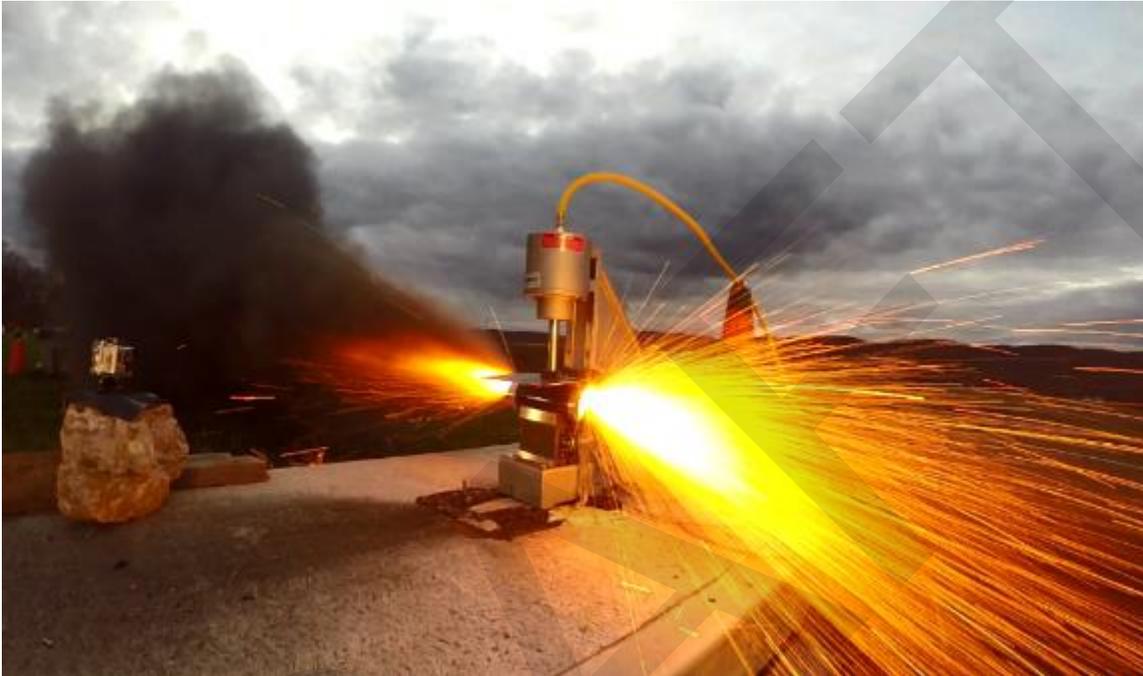
Figure 2. **Single Cell Nail Puncture Test**

The venting process implies the release of flammable electrolyte, generation of gases, or even a rupture of the cell casing. In most cases, all three happen just about simultaneously. Figure 2 demonstrates the intensity of the venting process, as exhibited by flames and gases energetically flowing out over approximately five seconds.

Figure 2 only shows what can happen to one cell, but in heavy buses, battery packs consist of hundreds of cells wired in a series/parallel configuration. In a high-quantity, multi-cell pack, such as an electric bus, the venting of just one cell can propagate its thermal energy to neighboring cells causing, a chain reaction until all cells rupture due to extreme thermal conditions.

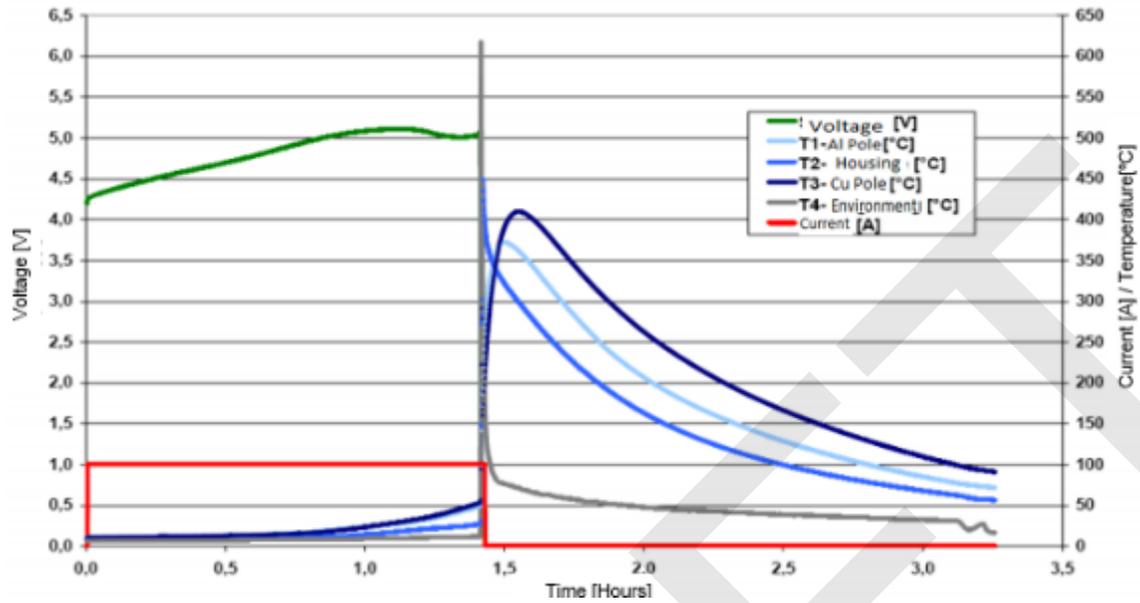
Figure 3. **Data from Manufacturer Overcharge**

Figure 3 presents voltage, current, and temperature from an overcharge test performed by the cell manufacturer. As seen in this figure, a fully charged cell (4.2 V at no load) was continuously charged at 100 A until the battery vented. During the test, the constant current increased voltage to approximately 5.2 V. This high potential between terminals and or other internal phenomena likely caused internal shorts, dropping the cell voltage to below 5 V. Once internal shorts or other energy releasing reactions occur, an abrupt increase in temperature rise/rate is seen.

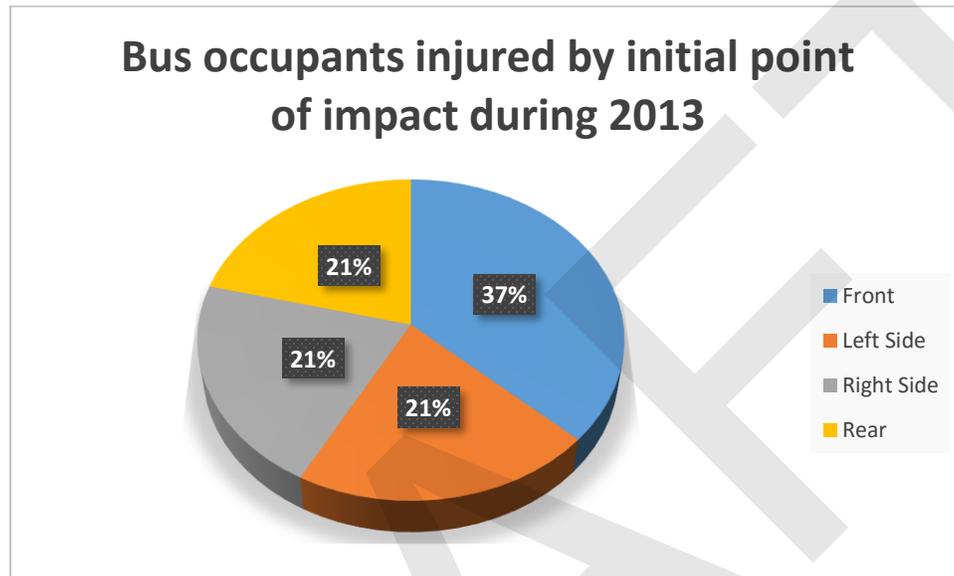
Figure 7. **Bus occupants injured by initial point of impact**

Figure 6 also indicates frontal impacts are the worst case scenario with the highest percentage of fatalities. In 62% of fatal accidents the impact came from the front. Lower fatality rates occur during rear (14%), right side (9%), and left side (8%) accidents. In Figure 7, the same data is presented for injuries and it is observed that the percentages are more equally distributed among each side of the vehicle.

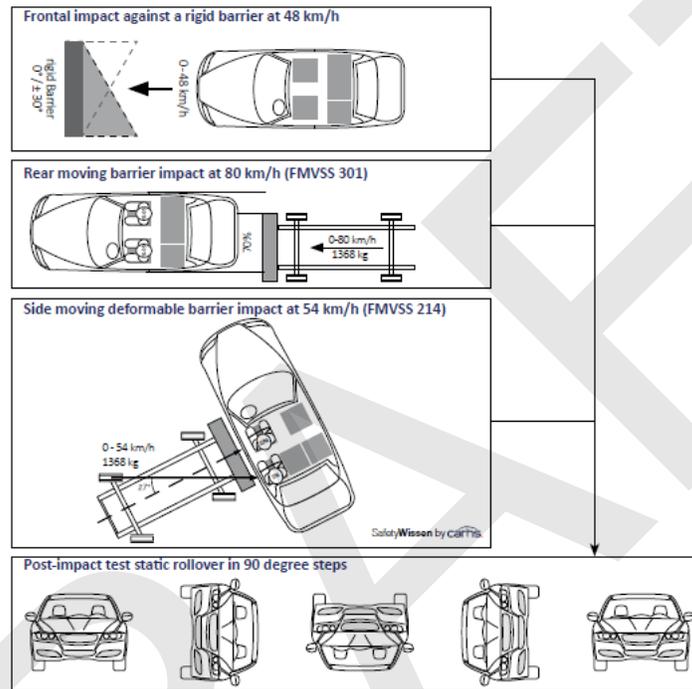
Figure 9. **FMVSS No.305 Tests Conditions**

Figure 9 details the test conditions of FMVSS No.305. According to the scope it's assumed that this regulation is not applicable to all kinds of buses since for example a full size bus is around 39.000 lbs. so it exceeds the weight specified in the scope so the standard does not cover all the buses.

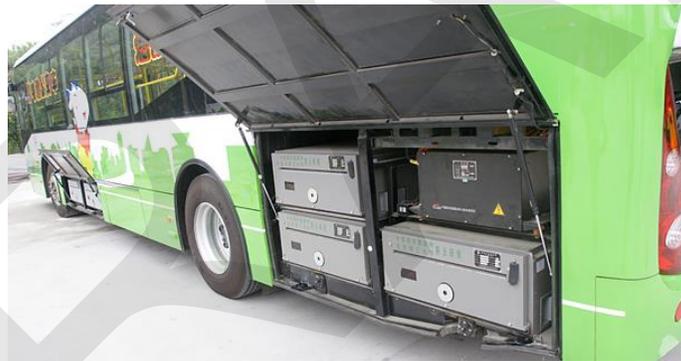
Figure 11. **Battery Packs on the Side of the Bus**

Alternatively, Figure 11 shows the battery packs mounted on the side. In some cases, cooling systems are also roof-top mounted. Also, the packs have to be properly enclosed and sealed to avoid any contact with water and prevent damage to any electronic components.

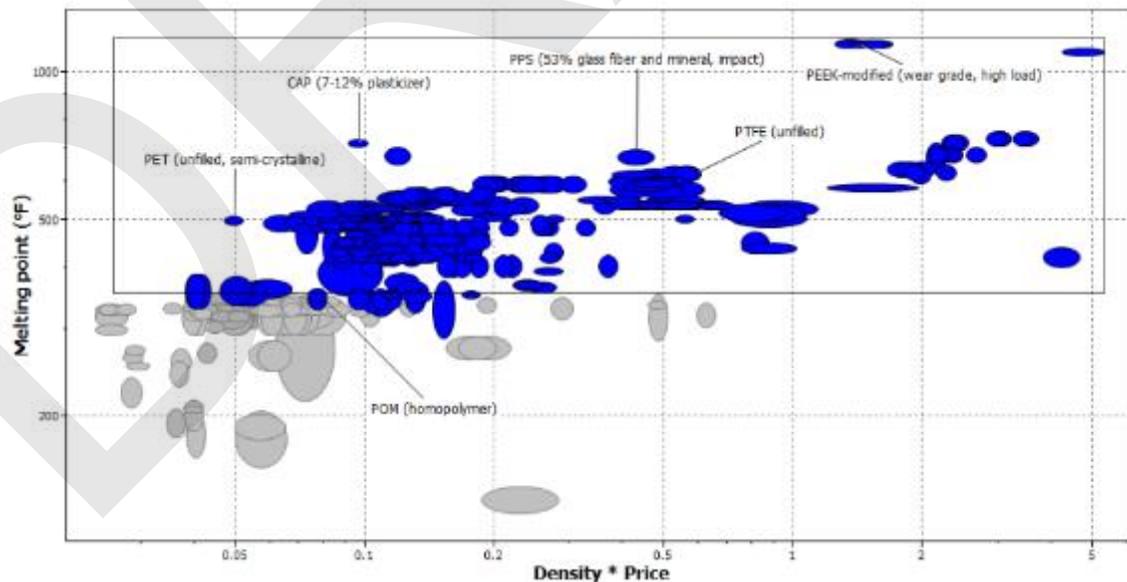
Figure 15. **Melting Points Above Acetal**

Figure 15 shows materials with a higher melting point than the Acetal. There are several choices but none of which is feasible due to the excessive price or density. Furthermore, the market doesn't demand these materials in the thicknesses needed to build the battery systems tested in the research, making it very difficult to get those specific materials with the thickness needed at an affordable price.

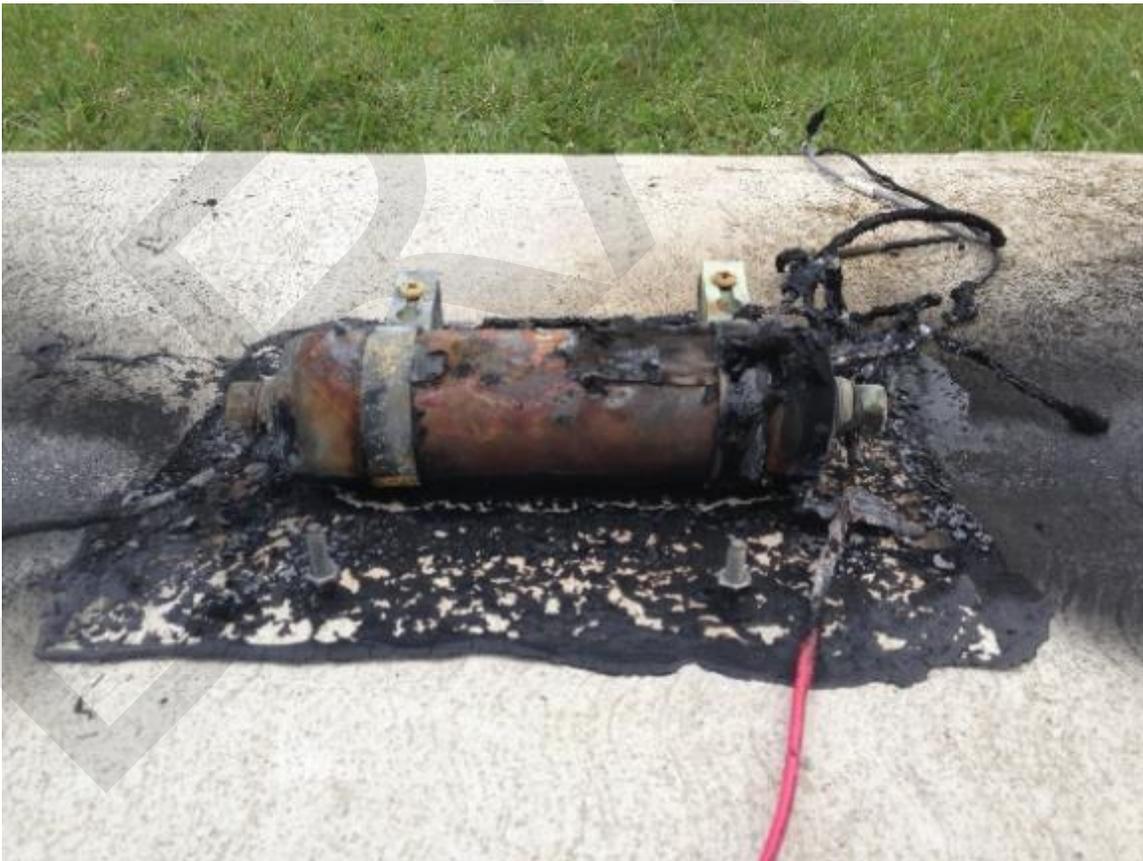
Figure 16. Results of a Single cell Acetal Test

Thus Acetal initially looks like a good candidate. Nevertheless, the tests performed showed that the flames coming out the battery and its casing temperature after an event are much higher in temperature than the melting point of the Acetal (160°C) so all the Acetal melted and ended up burning until it was gone. Thus, different materials with higher melting point were selected. Using the same relation between price and density versus melting point, the next candidates are sought.

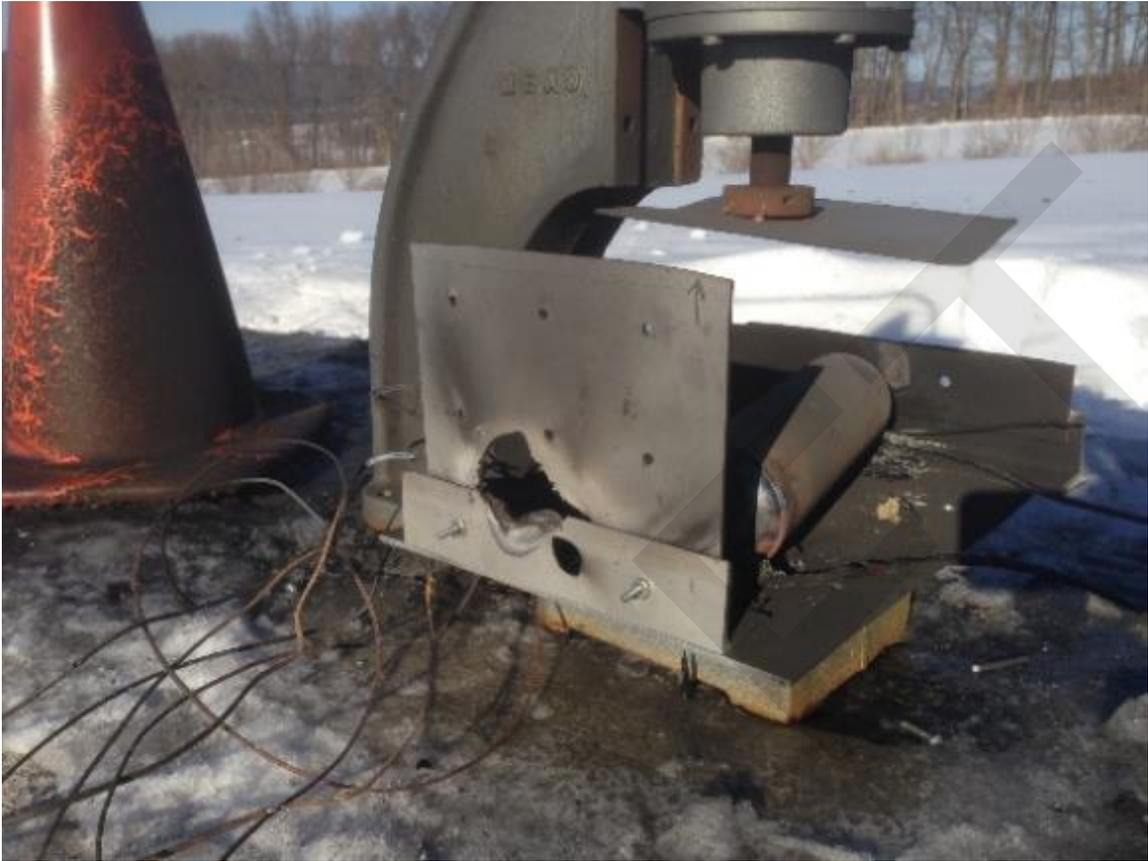
Figure 19. **Results from a Metal Test**

A test was performed to evaluate the thermal performance of metals by positioning a sheet of common 6061 aluminum alloy and mild steel at either end of a cell undergoing an overcharge. As Figure 19 shows, the flames that came out from the cell during the venting event melted the Aluminum. This proves that the flames/gasses are hotter than the melting point of the Aluminum which is approximately 600°C. On the other hand, the steel plate was able to withstand the hot gasses and remain intact. A mark where the gasses met the steel can also be seen on the far side of the cell in Figure 19.

This test validated the use of a relatively thin, 1/8" thick, mild steel with approximate melting point of 1300°C when considering materials for exposure to direct venting. If considering a ducting system or isolation within a pack, steel is recommended. Also, for small packs with no isolation, steel should be used to contain the event for as long as possible giving passengers time to evacuate the bus. Otherwise, materials such as aluminum or even plastic will allow the hot gasses to escape immediately and potentially cause more fire damage at a faster rate, thus making evacuation much harder for passengers and allowing less time to safely exit. Also, less time would be available for first responders to contain the event by cooling the pack with water.

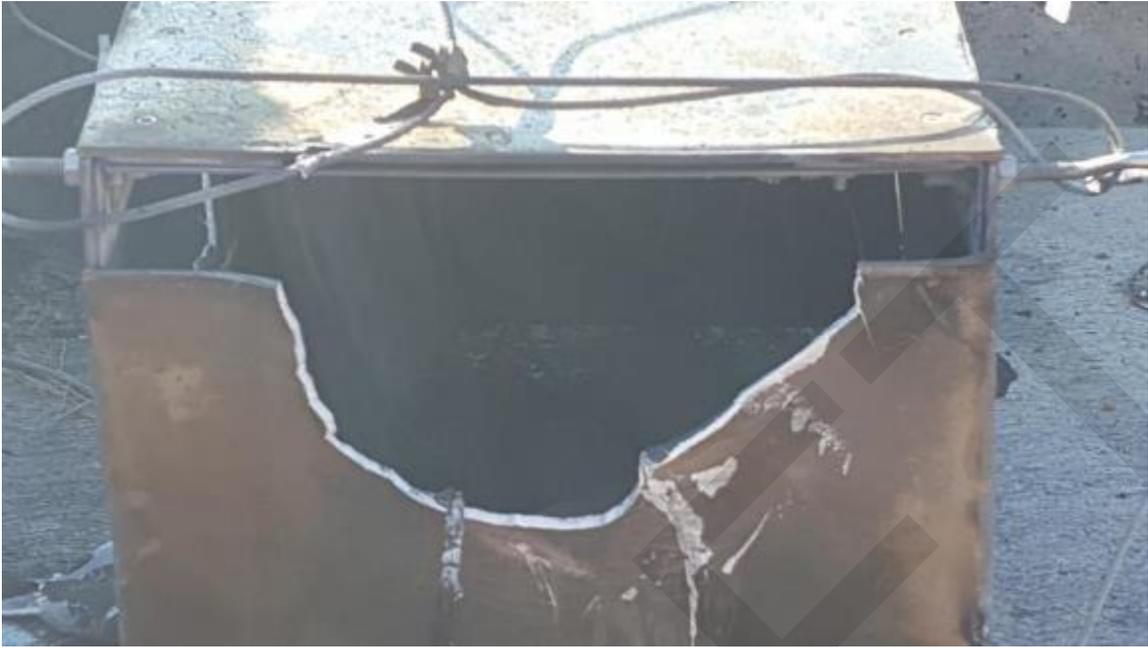
Figure 20. **Aluminum Enclosure After Overcharge Event**

A module level test of the same materials produced similar results as seen in Figure 20 and Figure 21. In this case the aluminum inner enclosure was damaged by the intense heat but the steel lid resisted damage. The Acetal battery separators were completely consumed by fire leaving only the stainless steel cell canisters.

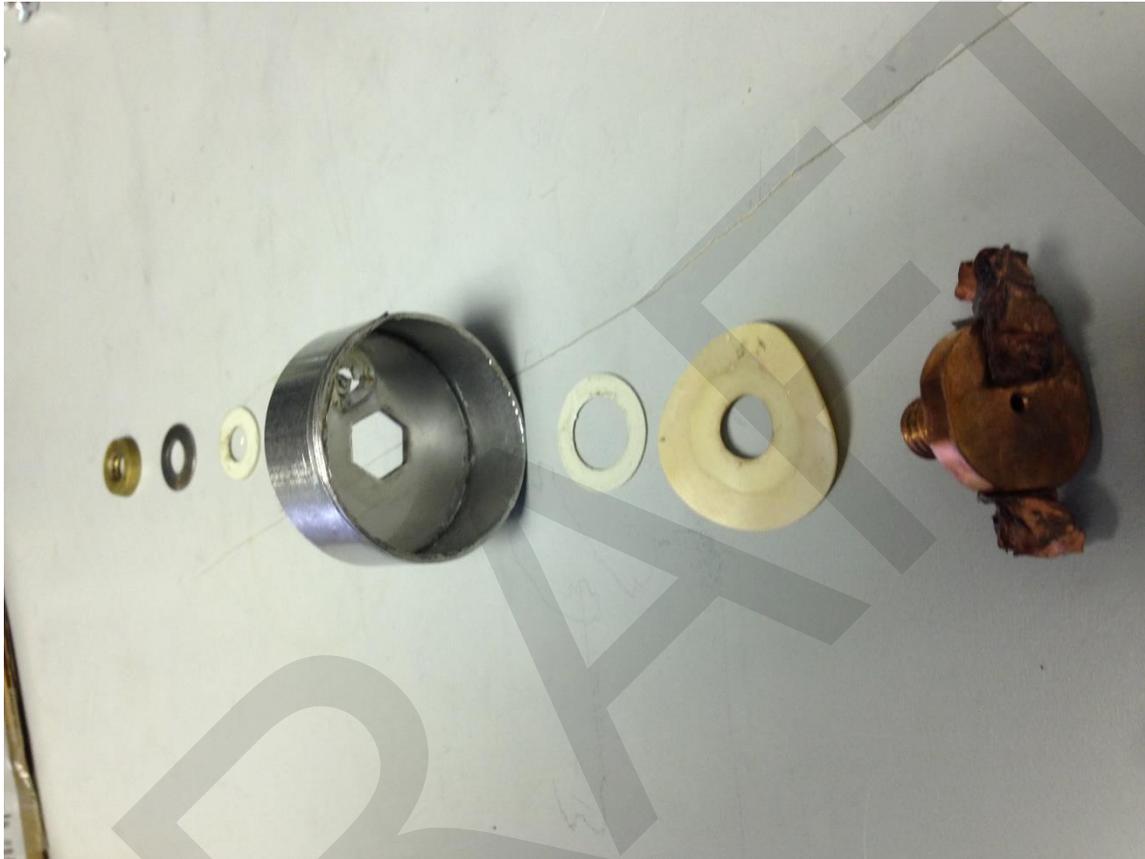
Figure 22. **Cell Internals – Negative Terminal Disassembled**

To understand the mechanisms inside a cell the research team, partnered with Pennsylvania College of Technology, safely discharged and disassembled a cell. Figure 22 shows the negative terminal of the GAIA cell and inside view of the pressure release and electrical isolators.

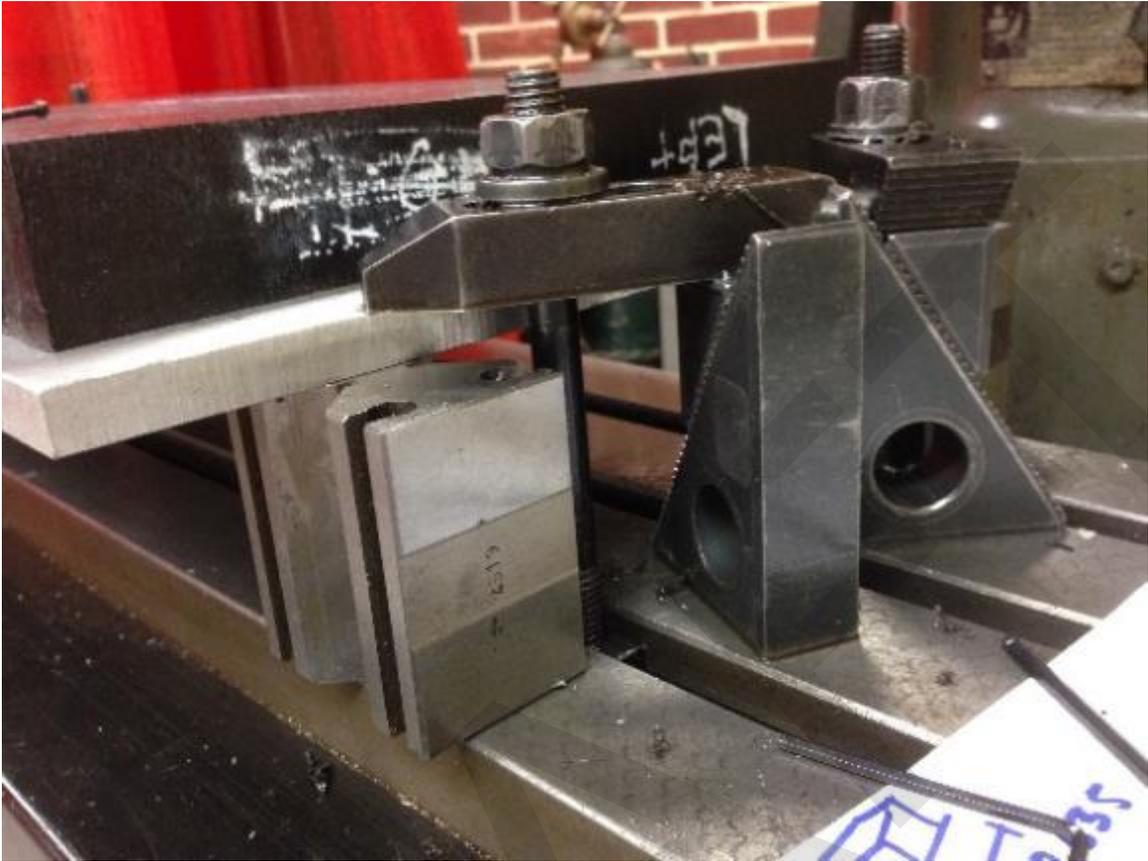
Figure 24. **Material Hold Down for Separator Machining**

An aluminum plate was used below the cell separator so that through holes could be machined without bottoming out onto the end mill table. Figure 24 shows the aluminum plate and preparations made on the machines prior to any cutting steps.

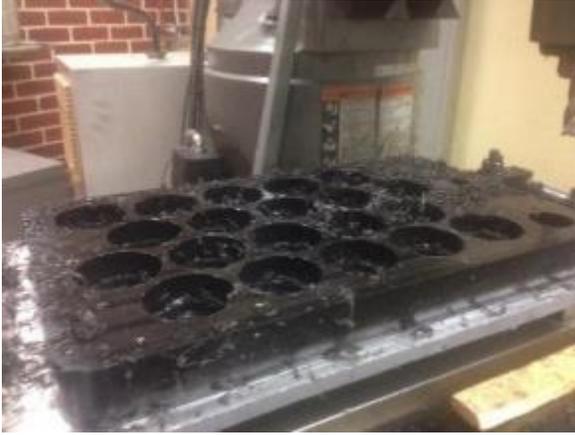
Figure 25. **Cell Pockets**

The following, Figure 25 and Figure 26 show some of the intermediate phases in the machine process while Figure 27 represents the final completed part.

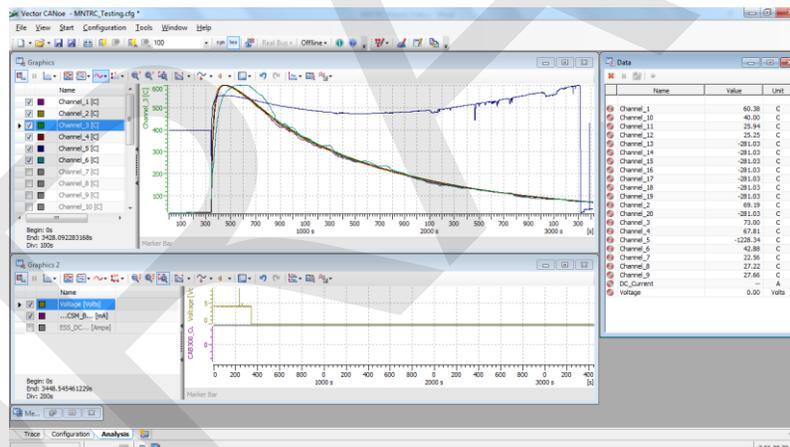
Figure 31. Monitoring the data through Vector CANoe

Figure 31 **Error! Reference source not found.** shows a typical CANoe interface set up that logged data from the cells during a test including voltage, current, and temperature in this case. Notice the screen is split into three main windows. The window on the top left graphs the temperature of each sensor versus the test time. The window on the bottom left graphs the voltage and the current. In the case of this nail puncture test no current is flowing therefore the current value is zero. The window on the right displays raw data variables and current values available on the CAN network which are available for graphing.

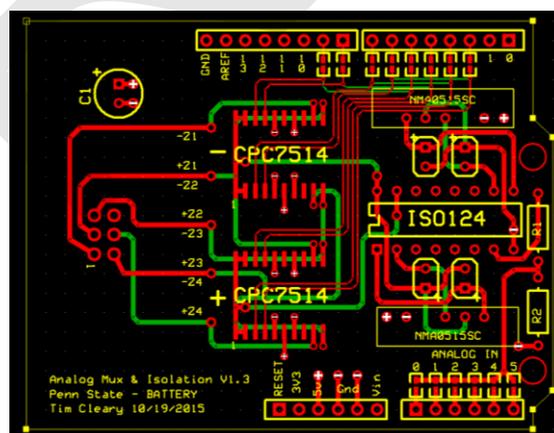
Figure 34. **Arduino Based Isolated Voltage Measurement PCB**

This third setup was necessary because the I+ME BMS hardware is limited to 4.5V per channel/cell and inadequate for pack overcharge tests. Therefore, the team developed their own switching and isolation circuitry to measure each module cell's voltage independently to send one cell voltage at a time to a single board computer (SBC) for A/D input.

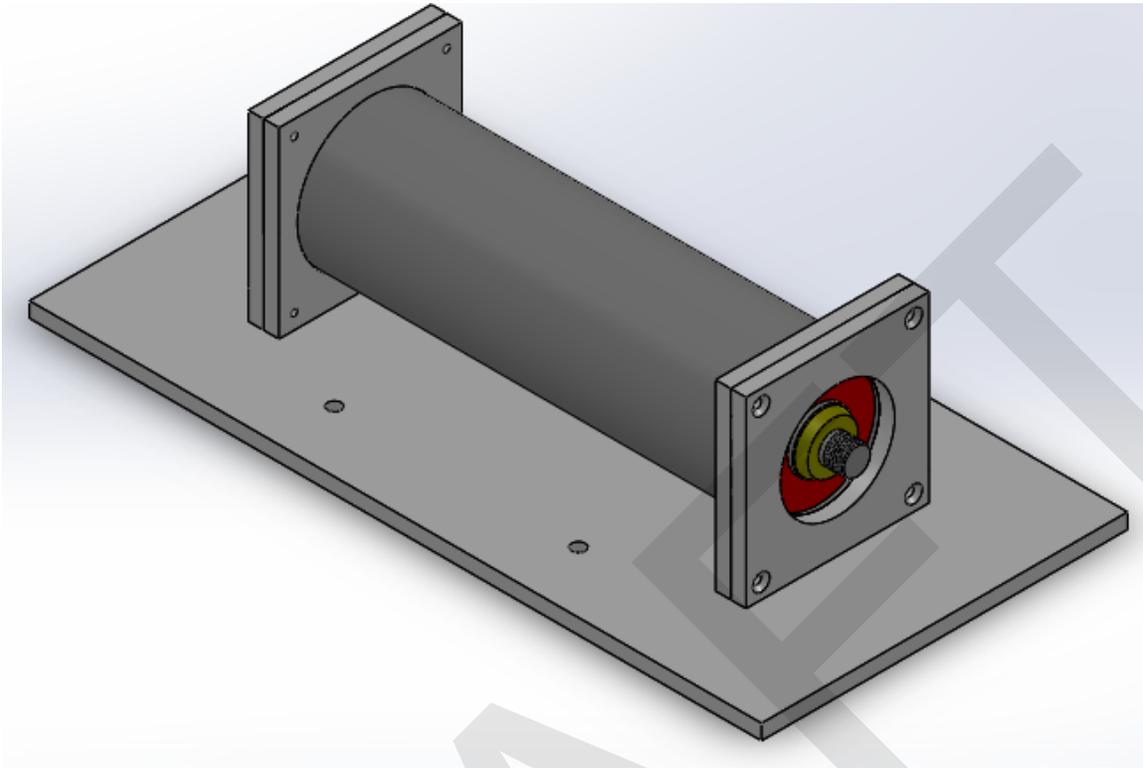
**Figure 35. Initial Single Cell Test Stand Design**

Figure 35 shows a solid model of the early concepts for a single cell test stand.

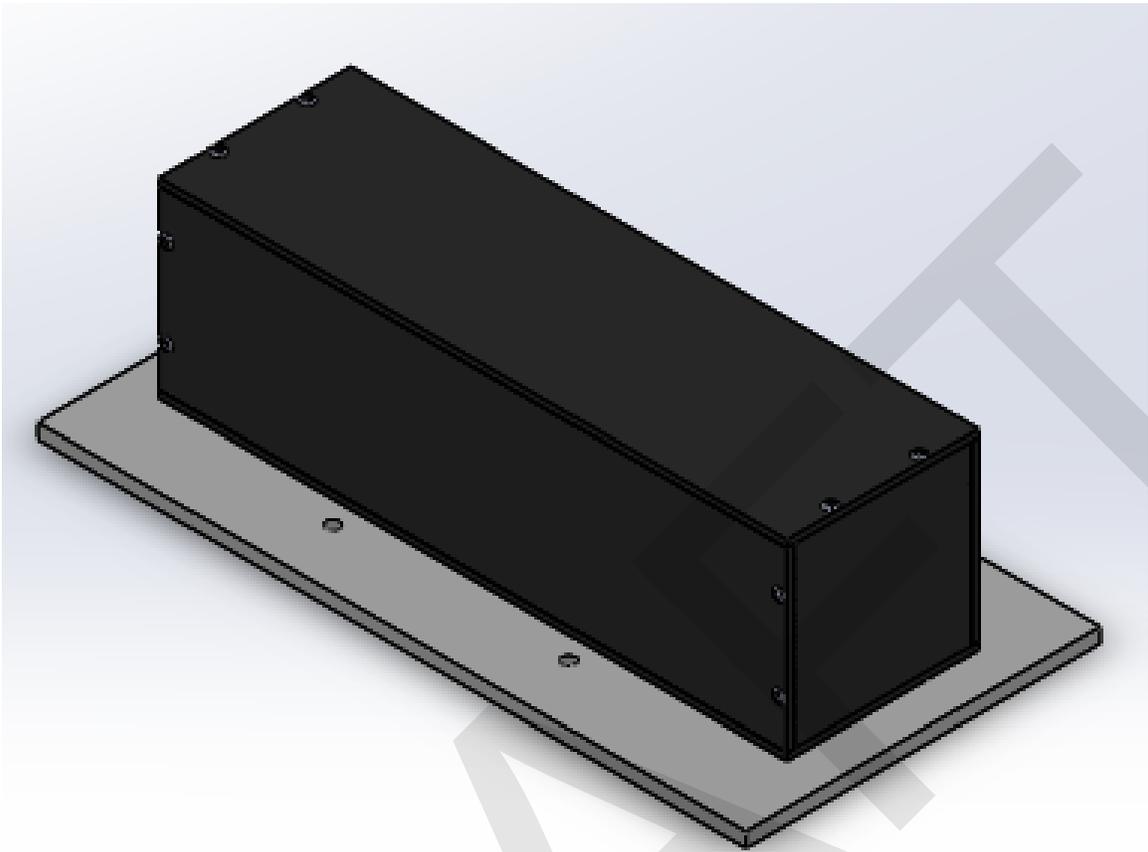
Figure 36. **Cell Enclosure**

The results of initial testing showed that the Acetal parts used to hold the cell were strong enough but shortly after an event they melted and burned until there was little material remaining.

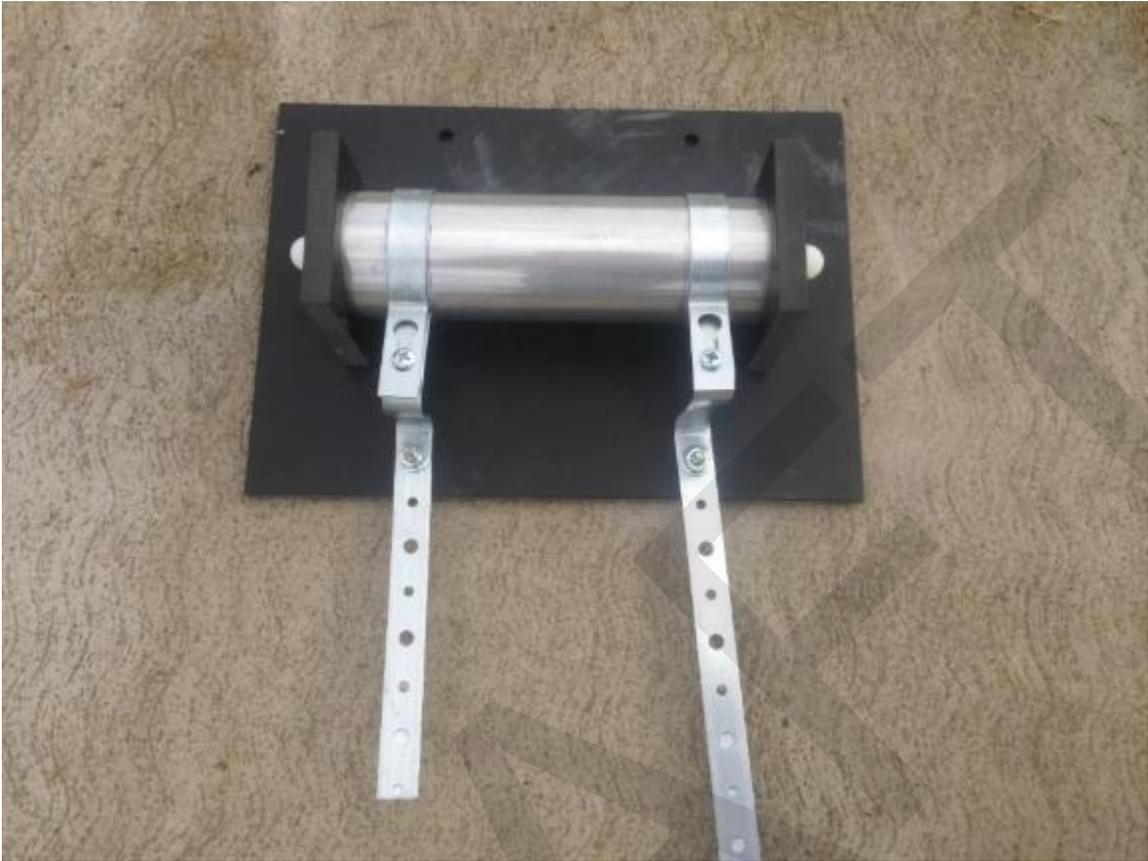
Figure 38. **Metal Straps**

To be sure that a cell would not escape during a venting or nail puncture test, metal bands, seen in Figure 38, were used to secure the cell.

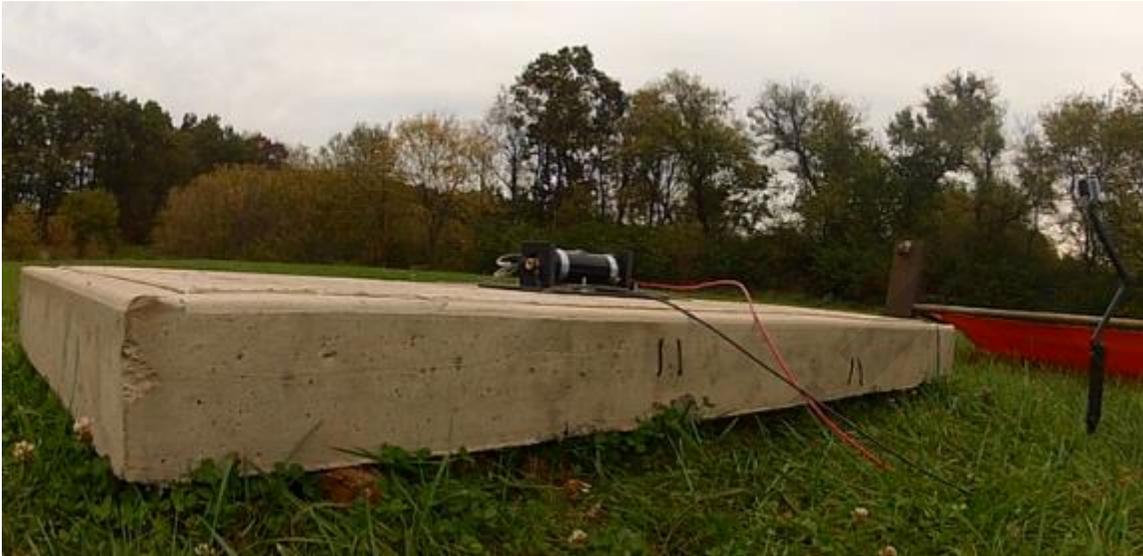
Figure 40. **Single Cell Overcharge Test**

The single cell Acetal test stand was bolted to a large concrete pad with metal straps as previously described. Figure 40 shows the concrete pad and single cell test stand, with charge cables, prior to the start of the first overcharge event.

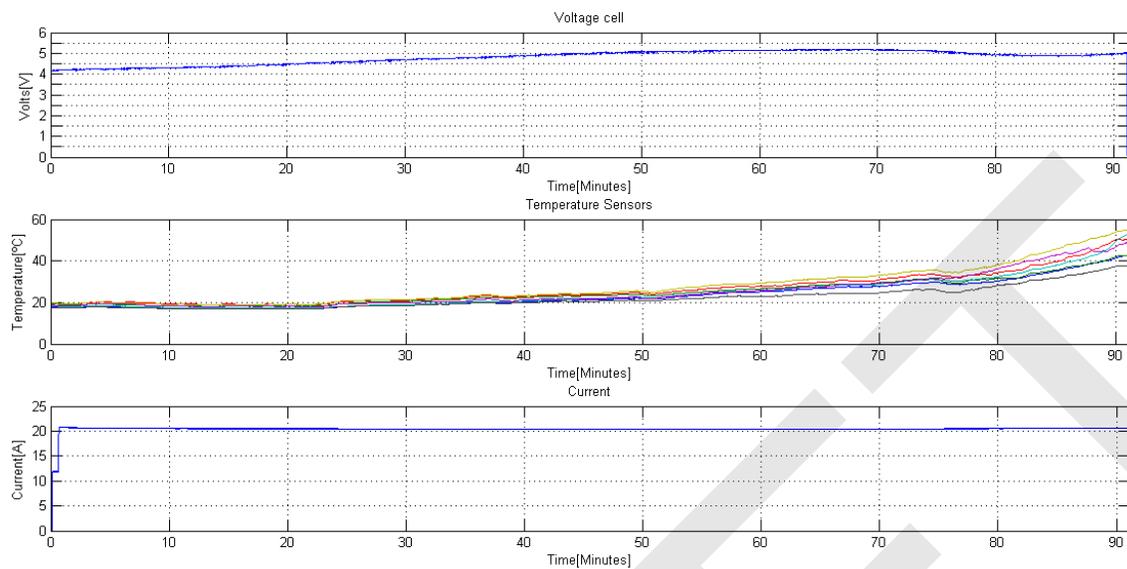
Figure 41. **Data from Initial Overcharge Test**

Figure 41 shows the data recorded via the CAN bus. Cell voltage, all temperatures and cell current up until the venting event were logged.

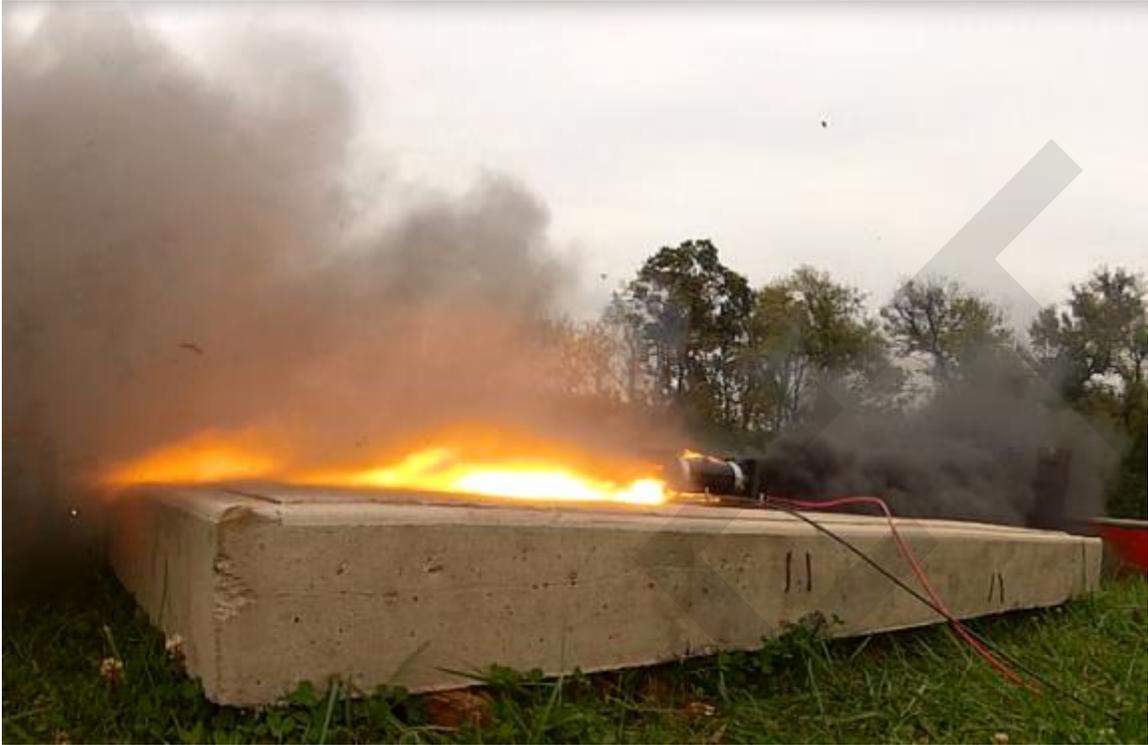
Figure 42. **Venting Cell – First Test**

The battery venting lasted roughly five seconds as indicated by flames and huge clouds of smoke. The magnitude of the event is displayed on Figure 42.

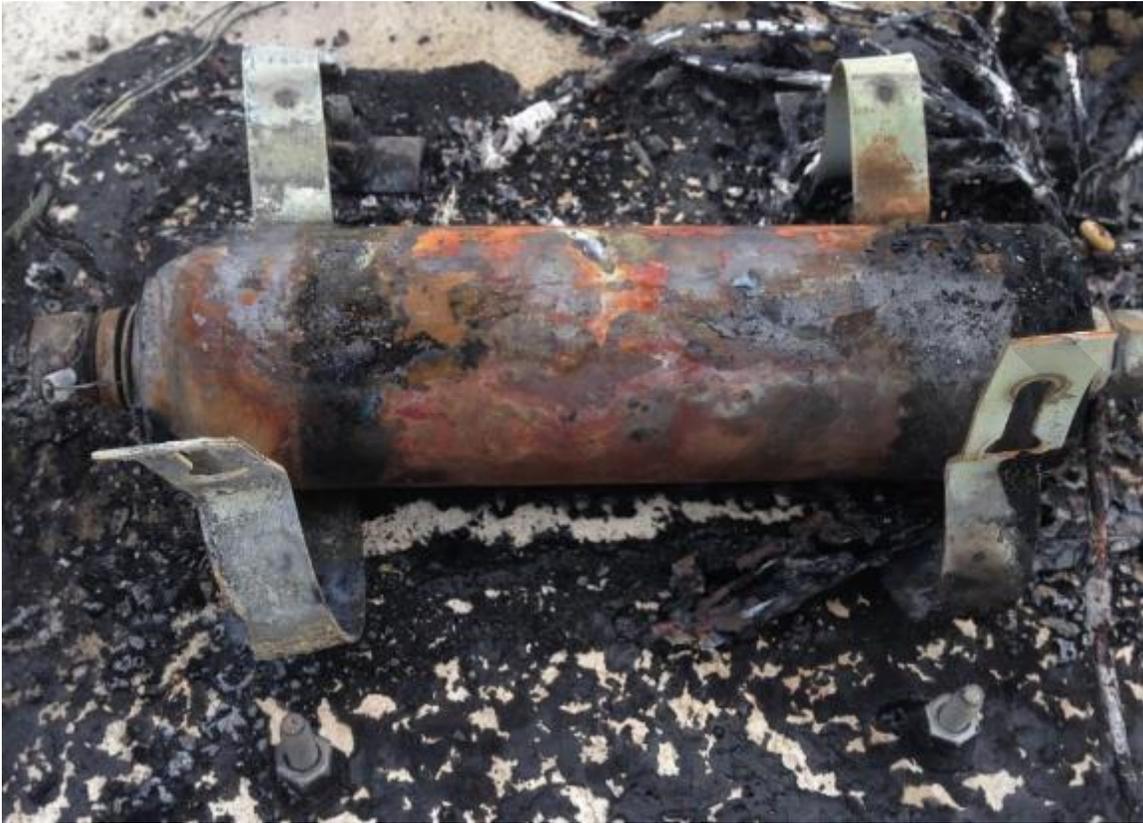
Figure 43. Cell, Hours After Venting Event

The single cell was held down to the concrete test pad through an Acetal cell holder and plate. The flames and the high temperature associated with the venting ignited the Acetal plastic which acted as a combustible and burned out until it was completely gone as seen in Figure 43.

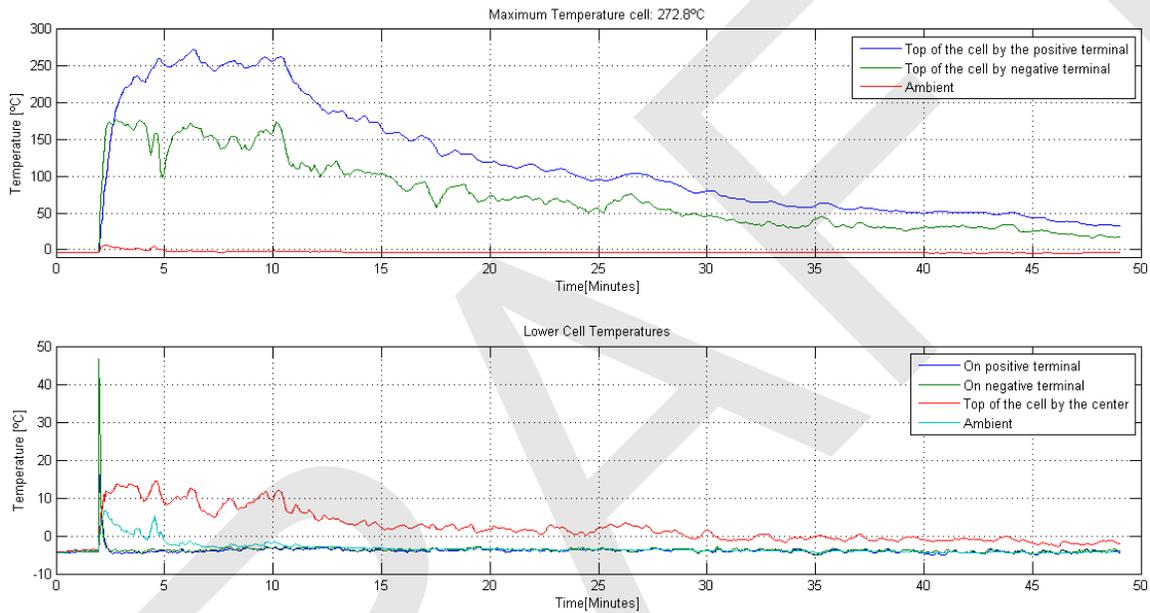
Figure 44. Acetal Nail Puncture – Cell Temperatures

Figure 44 shows cell temperature measurements in two charts. The top is scaled to the highest temperatures while the bottom is scaled to the lower values. The highest values were measured on the top of the cell by the positive and negative terminals peaking at about 273 °C and 175 °C respectively. The bottom chart shows little rise in temperature. Note, this test was performed in -3 °C ambient conditions.

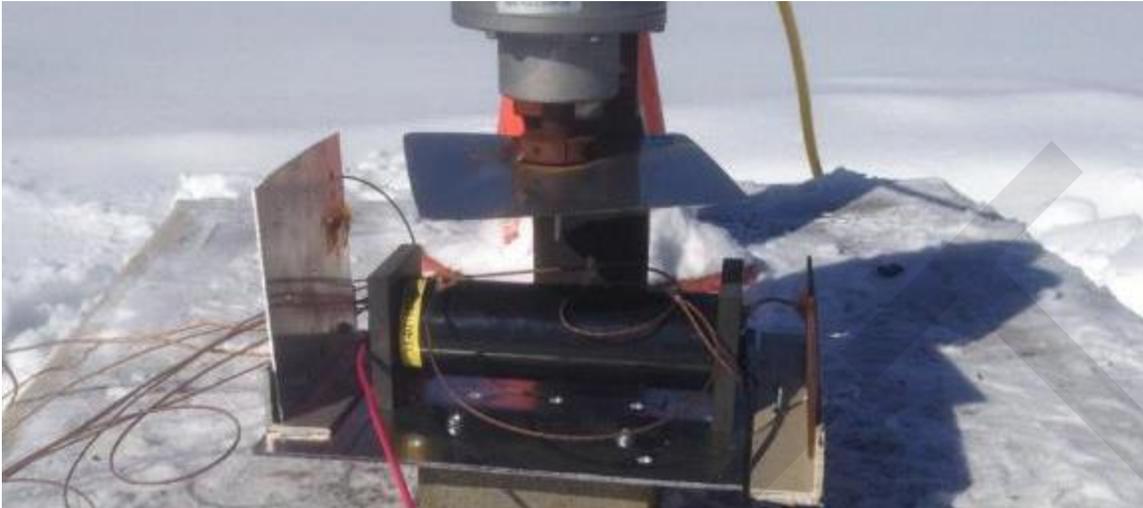
Figure 46. **Acetal Overcharge with Blast Shield Material Test Setup**

Figure 46 shows the setup of the cell and blast shield material. Two Acetal separators which were bolted down on an aluminum base held the cell. The aluminum base was mounted on the air press and the blast shield sheets were attached to the base through L type brackets.

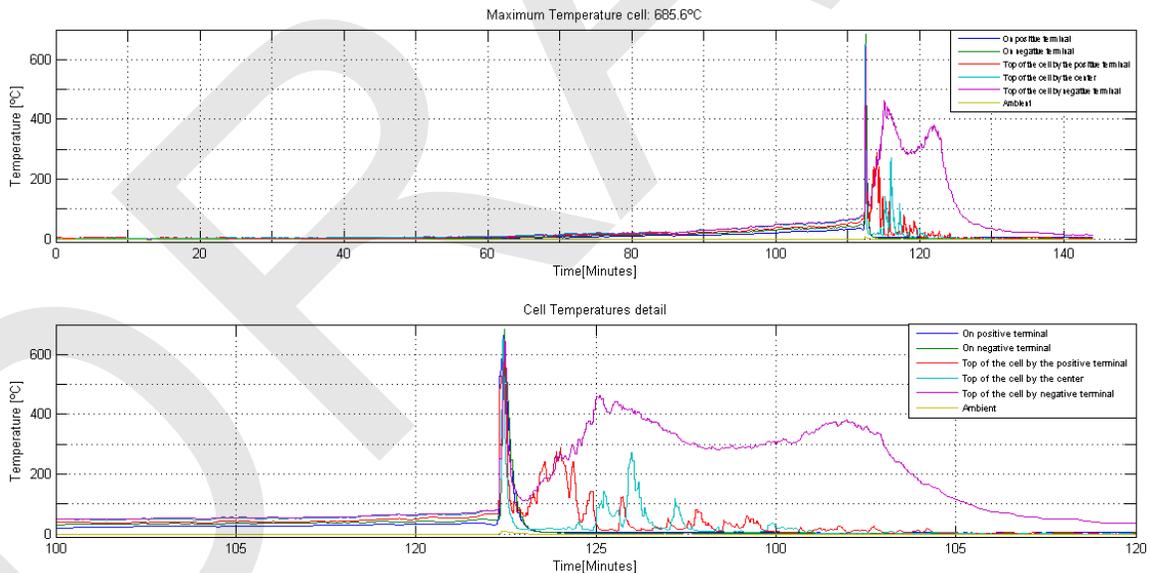
Figure 47. **Acetal Overcharge w/ Material – Cell Temperatures**

Temperature sensor location was identical to previous tests and again, just temperature data was logged during this test. These temperature readings are presented through the next few charts. Figure 47 shows two charts with the same data but at different time scales. The top chart shows the entire test from start, through the venting event, and until the end of the cells cool down. The bottom chart highlights the temperature profile immediately following the event.

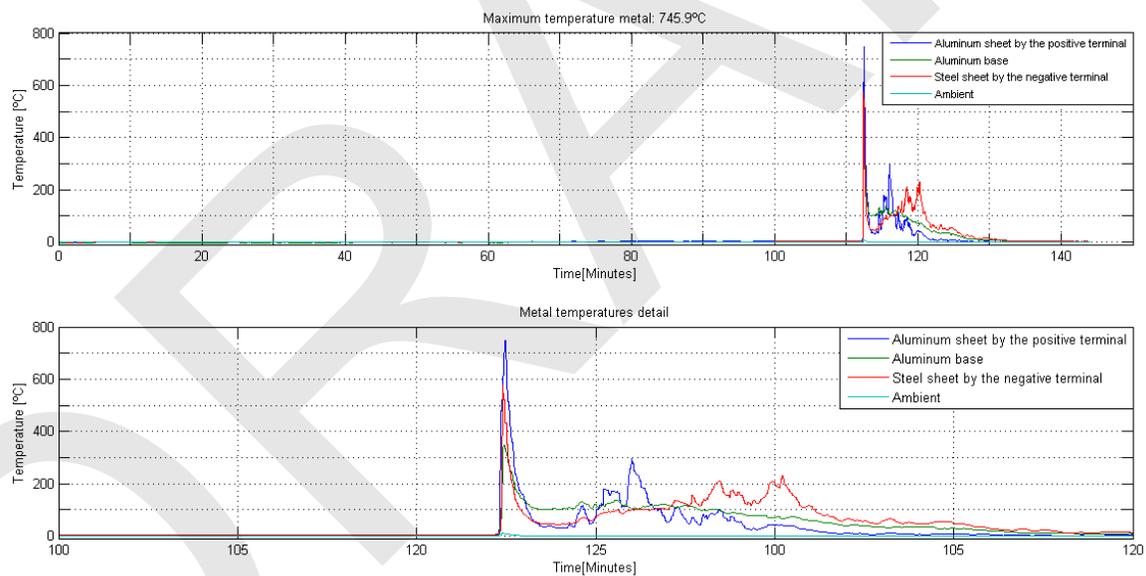
Figure 48. Acetal Overcharge w/ Material – Material Temperatures

The response of the metal is summarized in Figure 48. This first noteworthy point is that the metal exceeds temperature measurements from the cell itself. This is likely a result of the metal blast shields being in direct contact with the venting gasses while the cell surface temperature sensors are likely limited by the insulation properties of the cell casing. These material temperatures are assumed to be much closer to internal cell temperatures than the surface measurements captured from the cells exterior. The aluminum sheet experiences a temperature 100 °C warmer than the steel sheet. One of the causes of this response could be that the cell did not vent uniformly. Also, the thermal distribution properties of each material are substantially different. If the sensors were directly on the opposite side of the impact area more accurate readings would be possible. In reality, the sensors were at different distances from impact point of the gasses which also contributed to this difference.

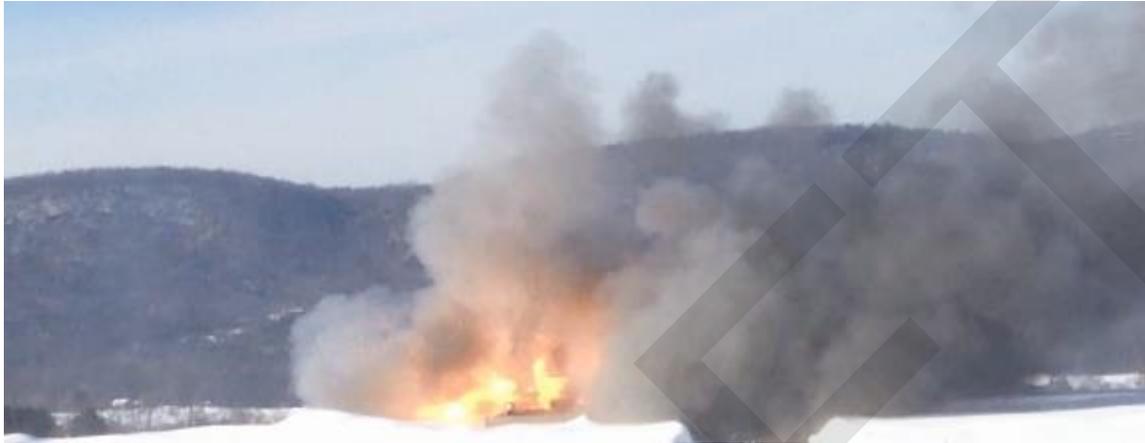
Figure 49. **Acetal – Overcharge with Material Test**

smoke escaping the cell stained the snow providing a radius for which to measure the effective distance debris can be expected to travel. Upon visual inspection, the smoke and flames traveled approximately 125 in from each side of the cell or in a radius of the same dimension.
