# **SAFETY OF LITHIUM NICKEL COBALT ALUMINUM OXIDE BATTERY PACKS IN TRANSIT BUS APPLICATIONS**

February 2016

## ABSTRACT

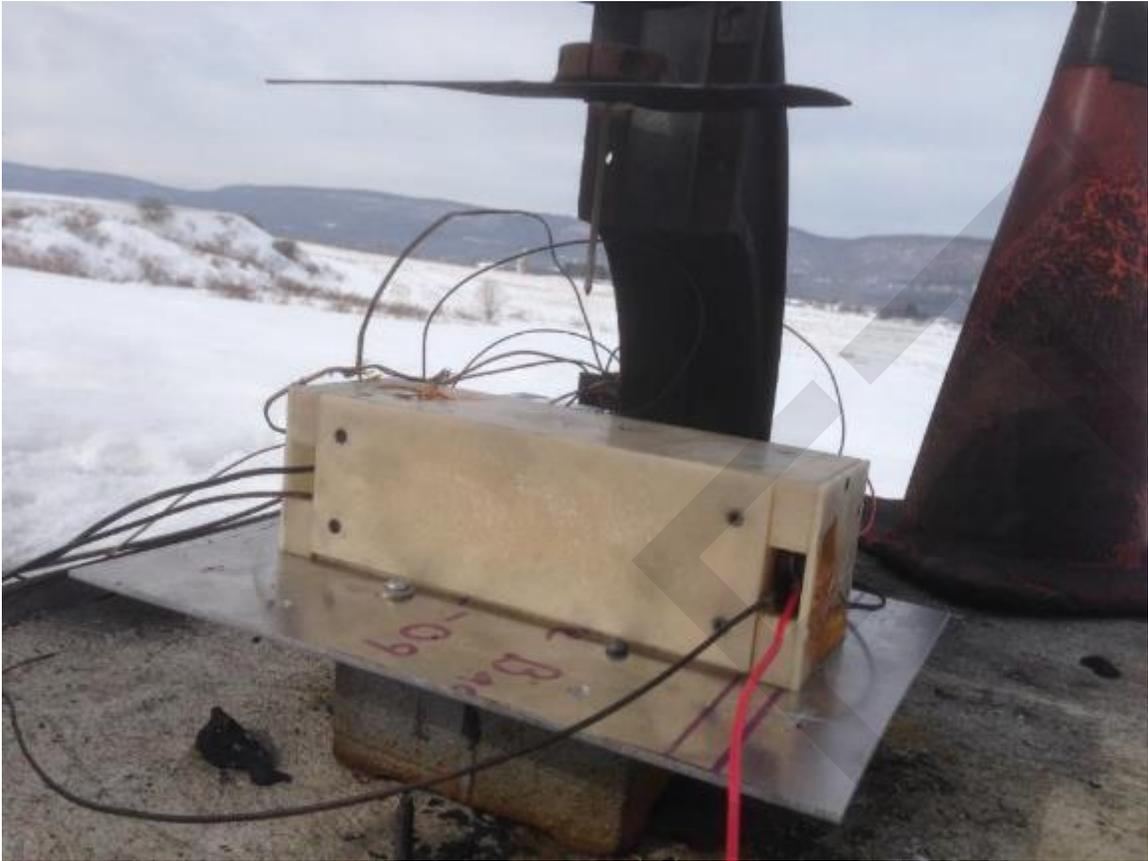
Figure 50. **Pyrophobic – Overcharge Setup**

Part of this research was to investigate fire suppression systems and fire prevention techniques using new materials and design. Pyrophobic Systems produces proprietary compounds that claim to both absorb, and suppress fires from spreading to adjacent areas. This research team formed a partnership with Pyrophobic by receiving donations of their materials in the form of machined components ready for testing in our single cell scenarios. To thoroughly test this material an overcharge test was commissioned. It is well known from previous tests that the most stressful scenario will occur from an overcharge venting event. For this test the cell was surrounded by a wall of Pyrophobic material with cell separators holding the cell at each terminal. Again the assembly was bolted down to an aluminum base that was also secured down to the air press just in case the cell failed to vent and a nail had to be put through to induce the discharge.

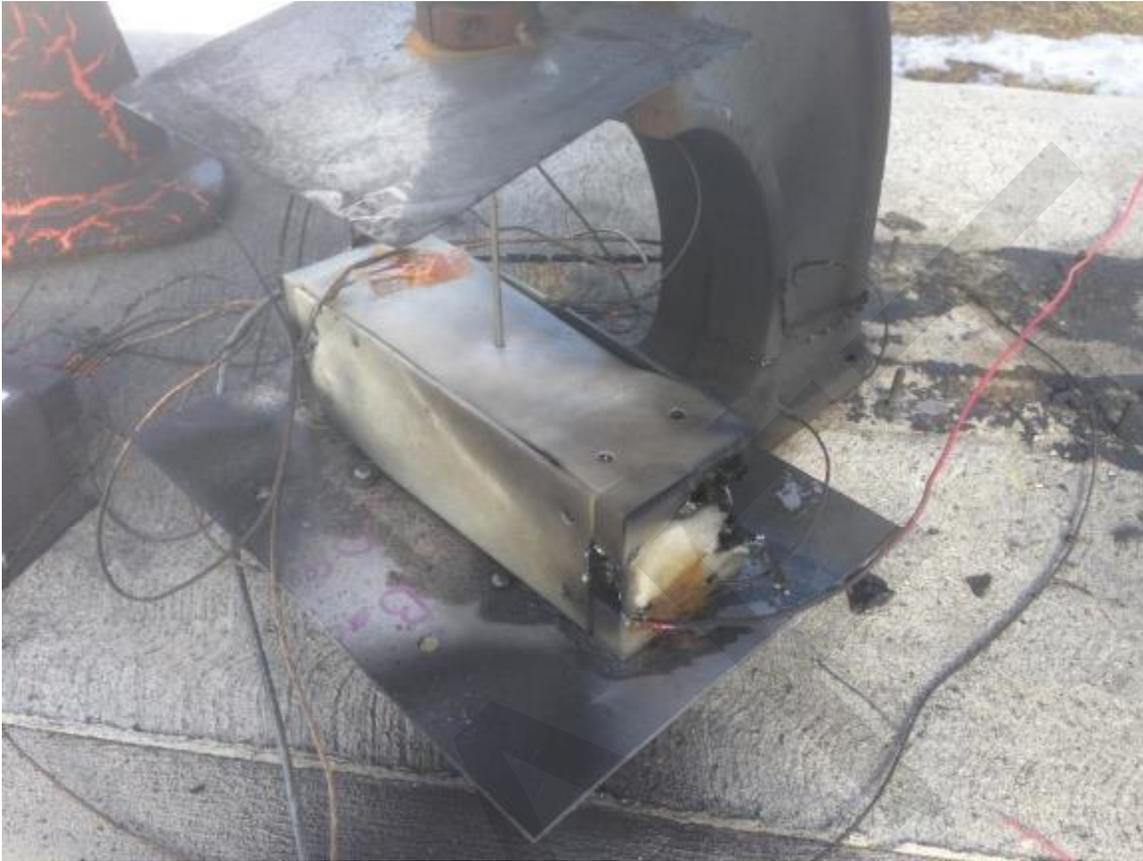
Figure 52. **Pyrophobic – Overcharge Results**

It is notable that the venting event resulted in a peak cell surface temperature of approximately 400°C which is considerably lower compared to the earlier tests.

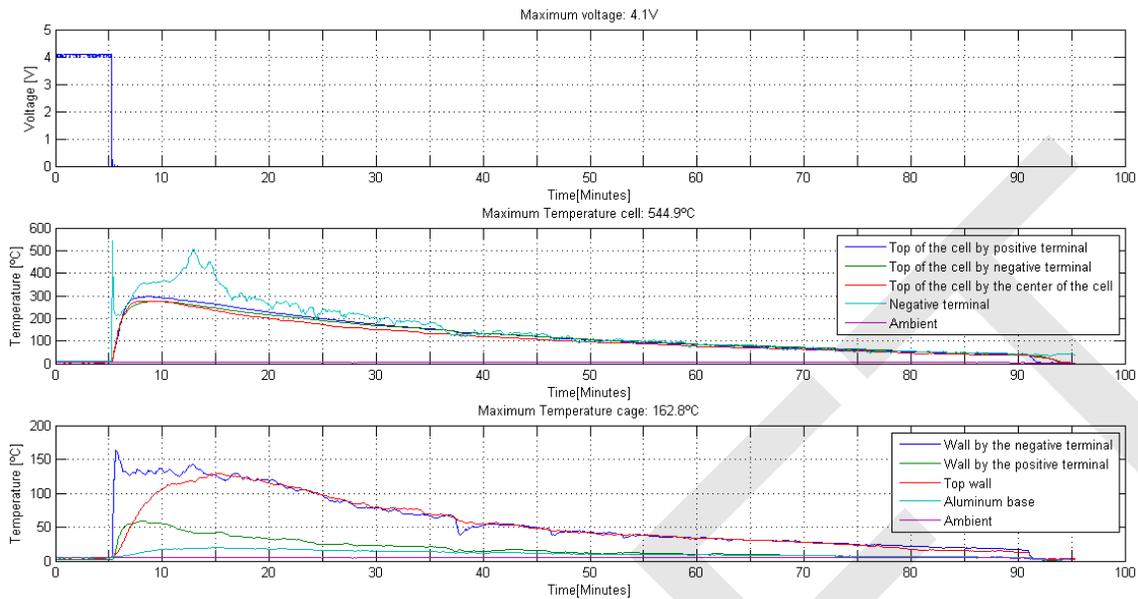
Figure 53. **Pyrophobic – Nail Puncture Data**

The test detailed in this section is the evaluation of the Pyrophobic phase change material under a nail puncture scenario. Temperature sensors were placed on the cell surface as in previous tests as well as all six parts of the cell and wall separators used in this design. To capture the thermal distribution during an event, but to also document how well this material held up to this extreme temperature and force, the temperature sensors were distributed along the cell and the surrounding walls, all made of the same Pyrophobic material. Figure 53 shows the voltage and temperature data recorded during this test.

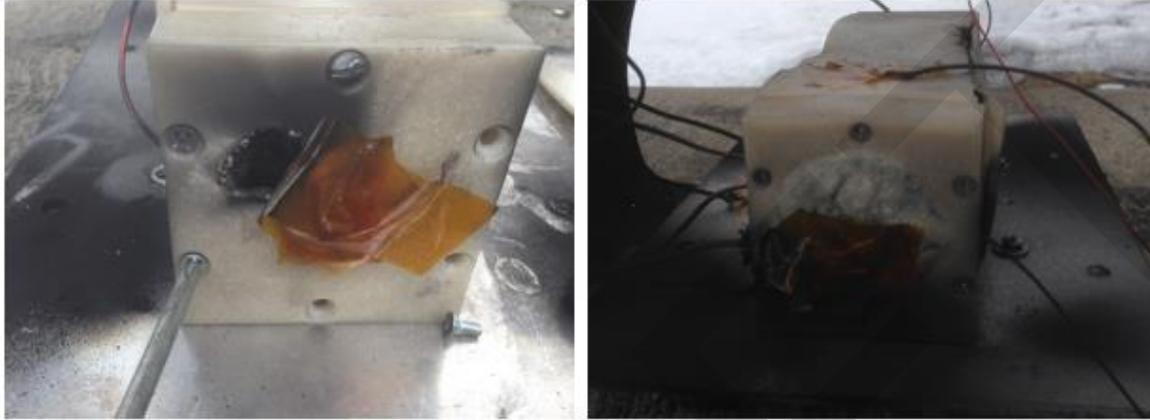
Figure 54. **Pyrophobic Material Results**

to the negative terminal. The images of these terminal covers may show why this happened. The positive terminal cover was quickly punctured by the venting gases while the negative cover seems to have contained these hot gasses and only vented on the side opening of the cell separator.

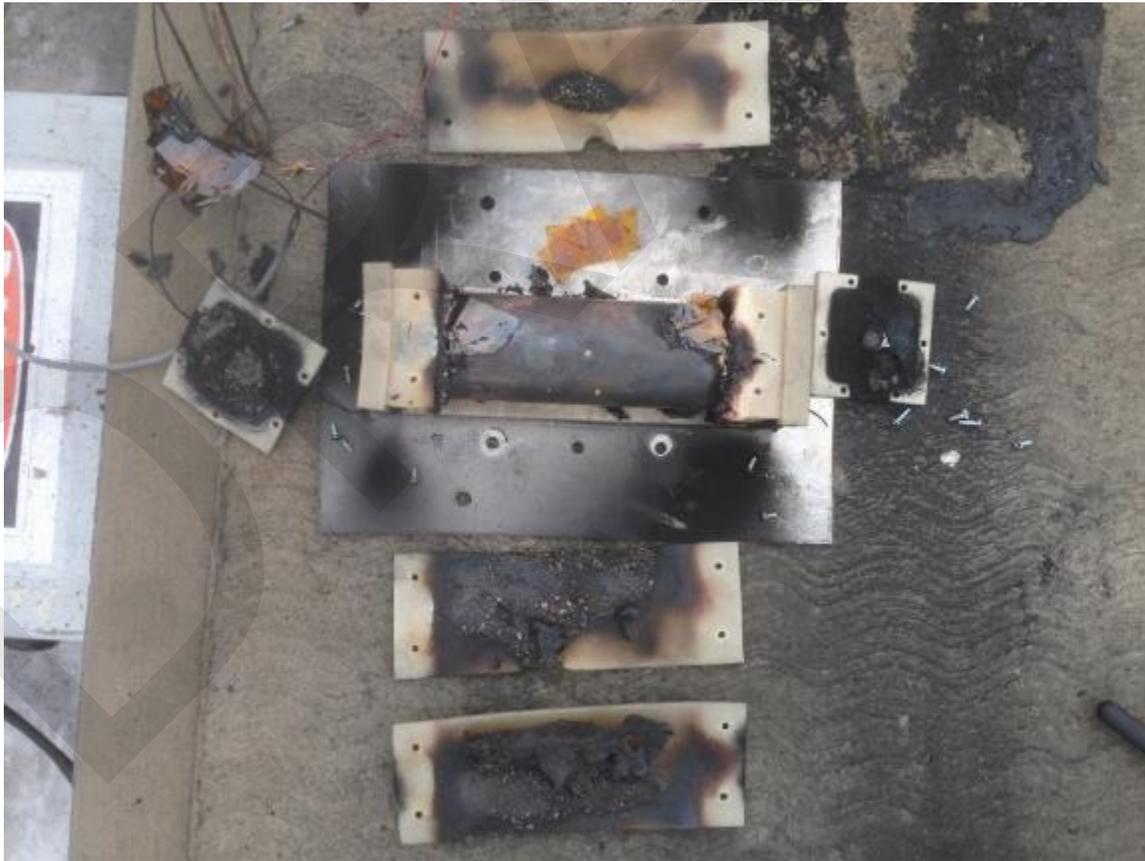
Figure 55. **Pyrophobic Material After Nail Puncture**

Following a long cool down period all the material including each cover and wall plate was removed and analyzed.

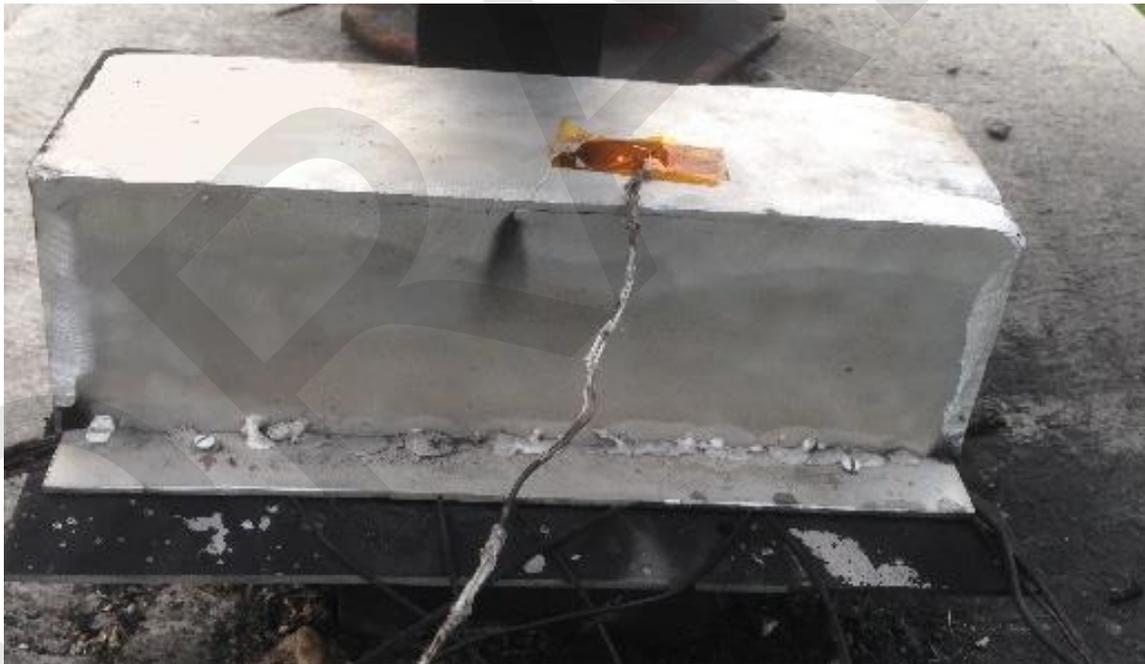
**Figure 56. Pyrophobic – Overcharge with Enclosure Setup**

The housing was bolted down on the same aluminum base that held all previous assemblies on the air press as seen in Figure 56.

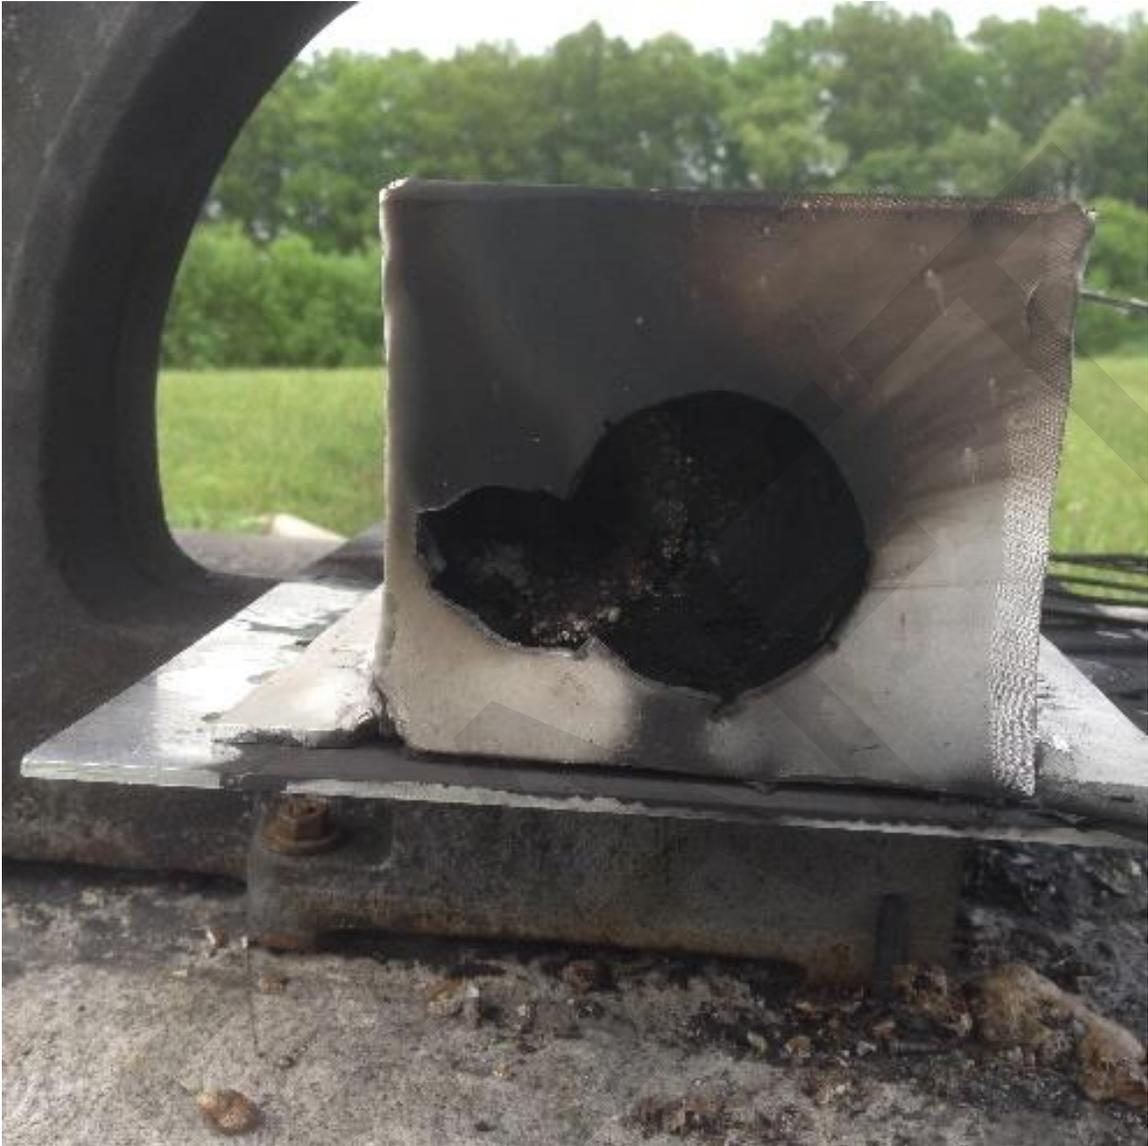
Figure 58. **Pyrophobic Enclosure Vent Opening**

Figure 58 shows the machined opening, larger diameter hole, and the smaller opening cut by the venting gasses.

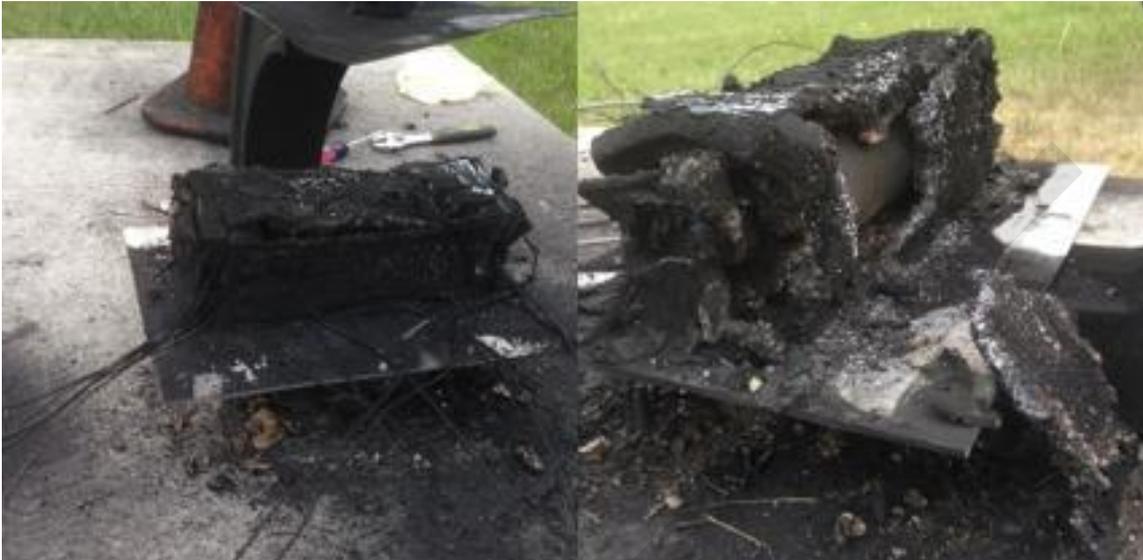
Figure 59. **Pyrophobic Overcharge with Enclosure Material Results**

Figure 59 shows the results of the material inside the enclosure. Clearly this material is more charred and not as strong or capable of holding a cell as the test performed without an enclosure.

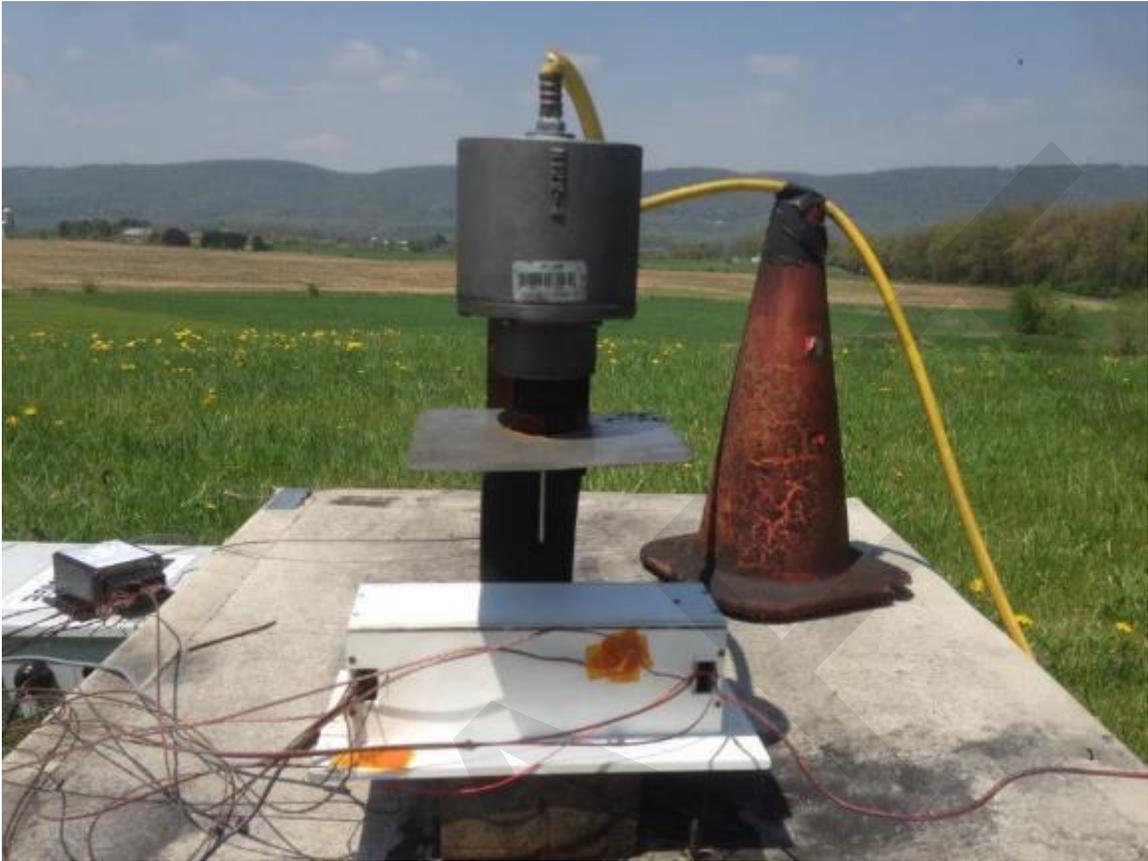
Figure 60. **PET – Overcharge Setup**

The thermal response of a PET material used in a single cell test stand was also evaluated. This section details the setup and results of an overcharge event using PET to both hold and enclose a single cell. Figure 60 shows the setup for this test. As with previous tests, the cell is securely mounted to the air press and equipped with temperature, voltage and current sensors.

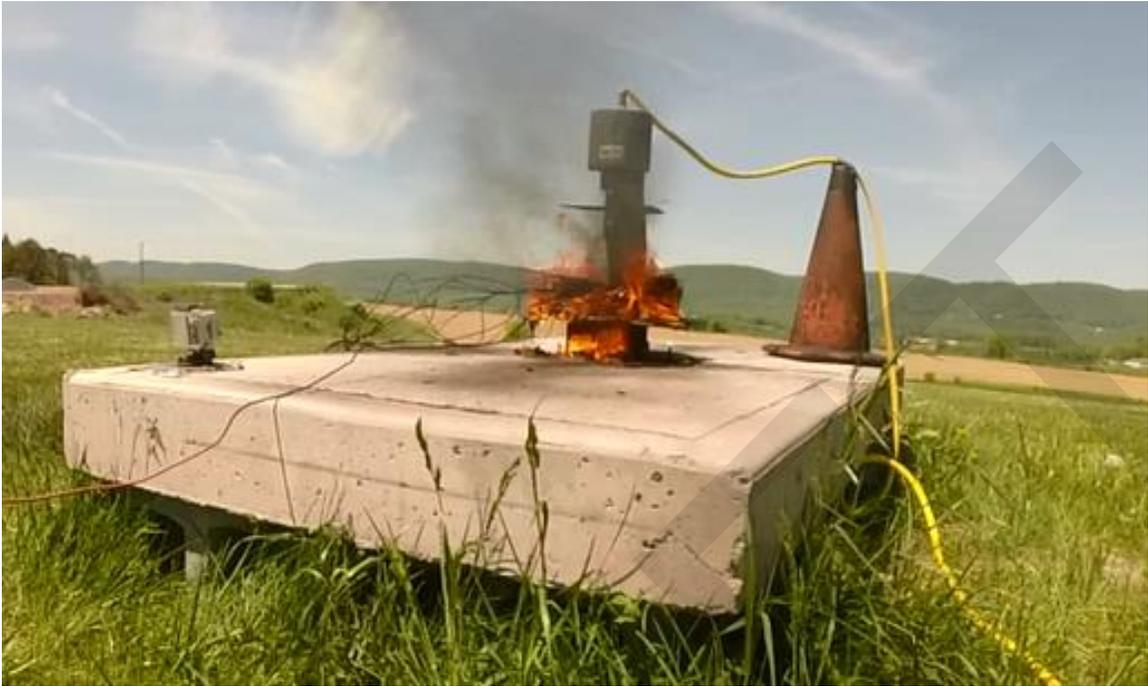
Figure 63. **PET – Material Result**

Not all tests result in exactly the same temperature measurement distribution. Some show that the positive terminal is hotter than the negative. However, in this test since the PET material caught fire, as seen in Figure 63, most sensors detected extremely high and sustained values.

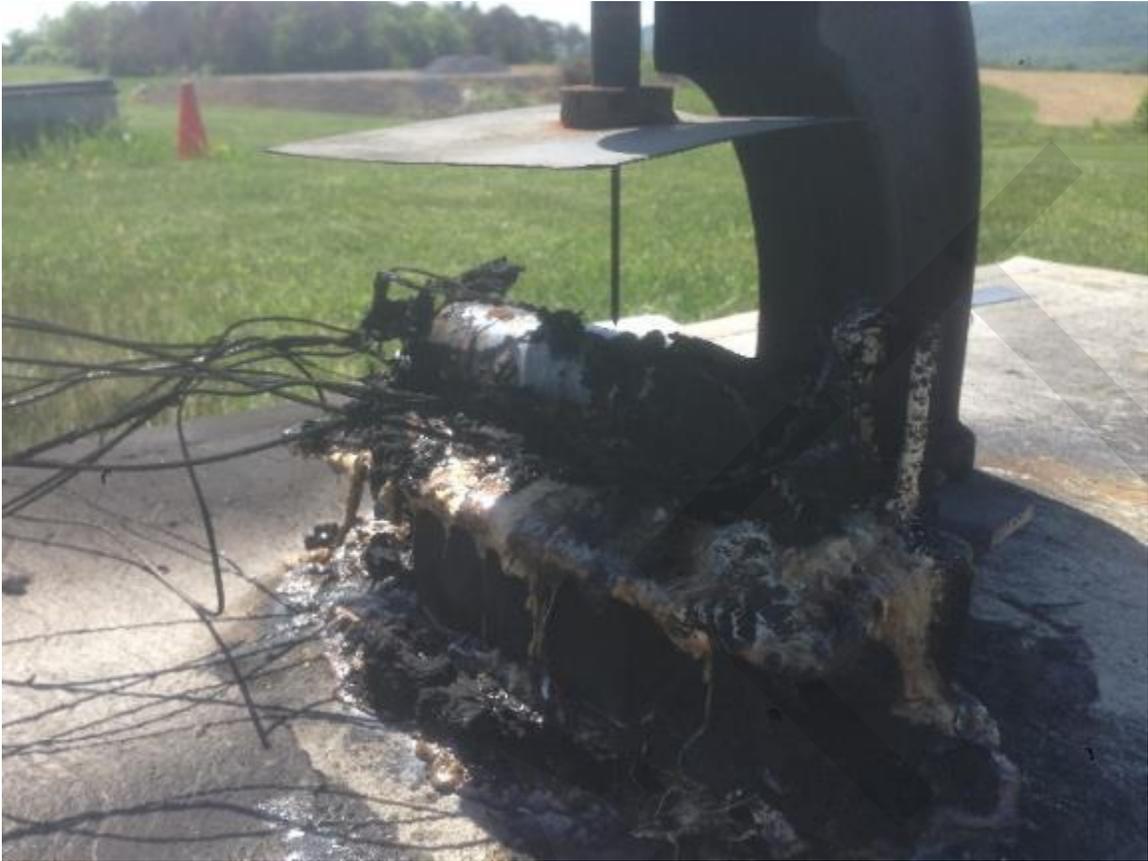
Figure 64. **PET – Material Result 2**

Figure 64 shows the remains after the PET enclosure melted down. The only part not damaged was the base which was made of a substantially thicker, 0.5in plate.

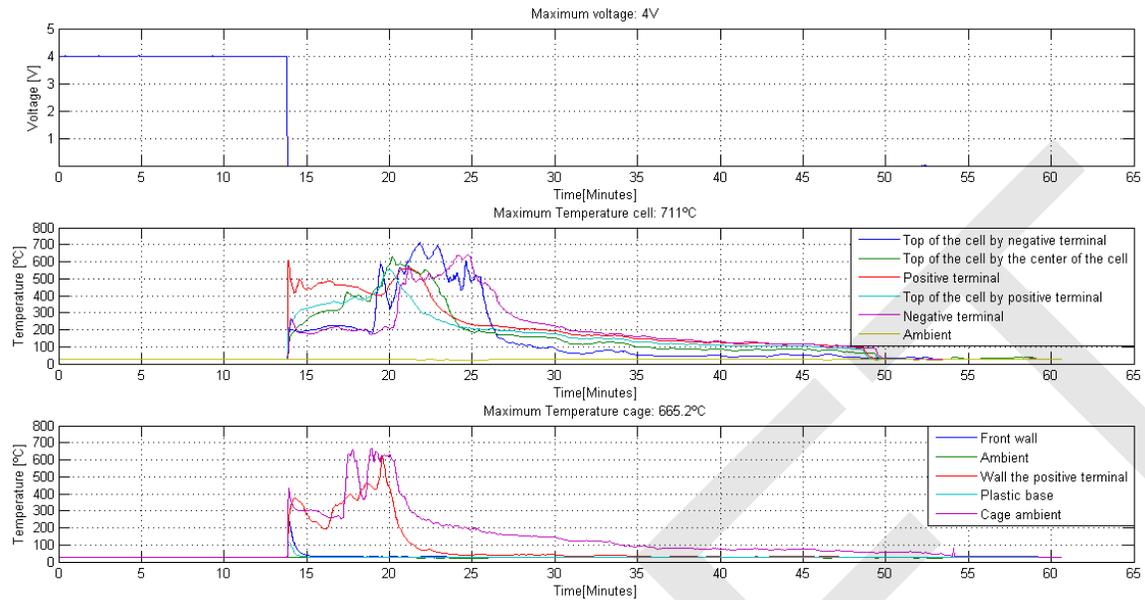
Figure 65. PET – Nail Puncture Data

Voltage and temperature data was gathered during this test. Figure 65 shows the logged data.

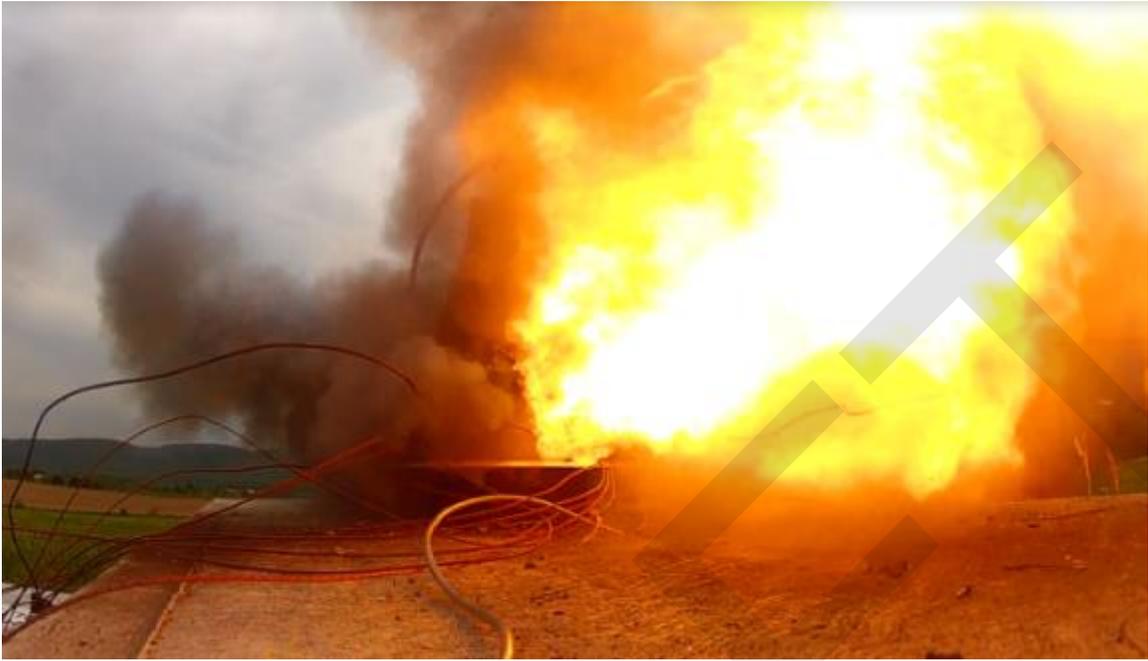
Figure 66. **PET – Positive Venting First**

In a review of the recorded video some notable points stand out. The positive terminal was the first to reach the high temperatures recorded and was also the first side to experience a disc rupture, resulting in hot gasses venting and flame. This can be seen in Figure 66, note the right side represents the positive terminal.

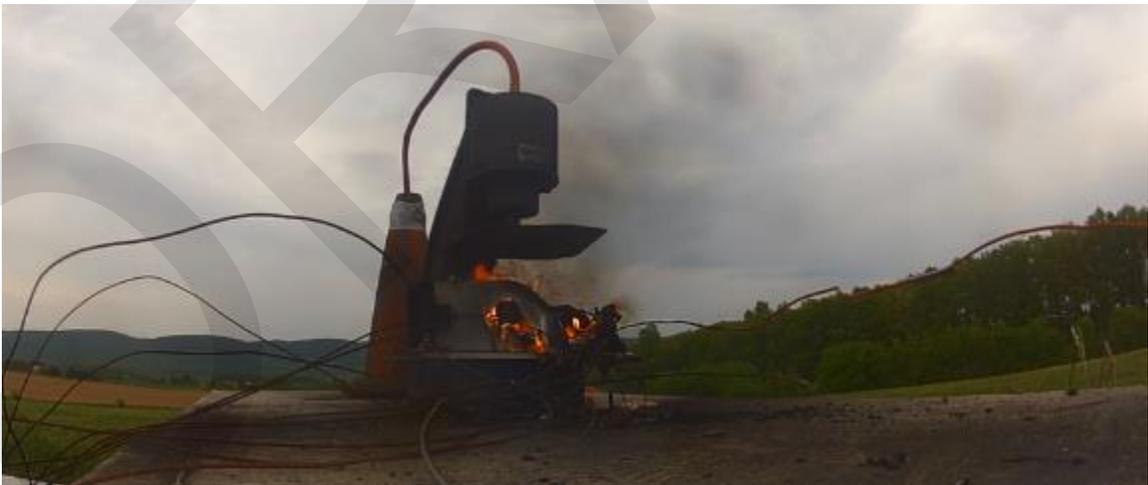
Figure 67. **PET – Nail Puncture Material Result**

As with the previous PET tests the material caught fire and burned until completely gone. The fire lasted about ten minutes which according to the graph correspond to the period of time between the 15th and 25th minute when the cooling down profile started. The fire a few minutes after the nail puncture can be seen in Figure 67.

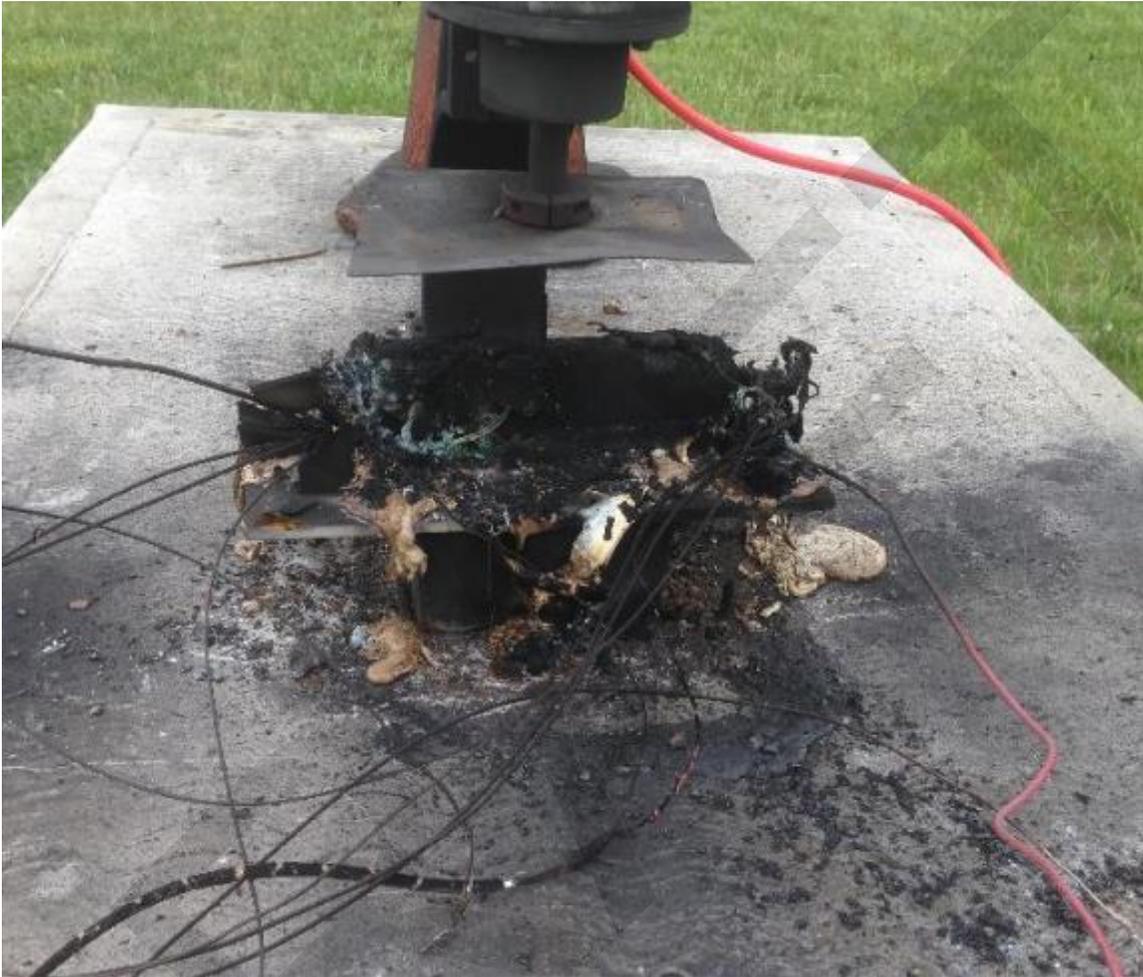
Figure 68. **PET – Nail Puncture Results 2**

was nonexistent after a few minutes and only the cell case and plastic base remained.

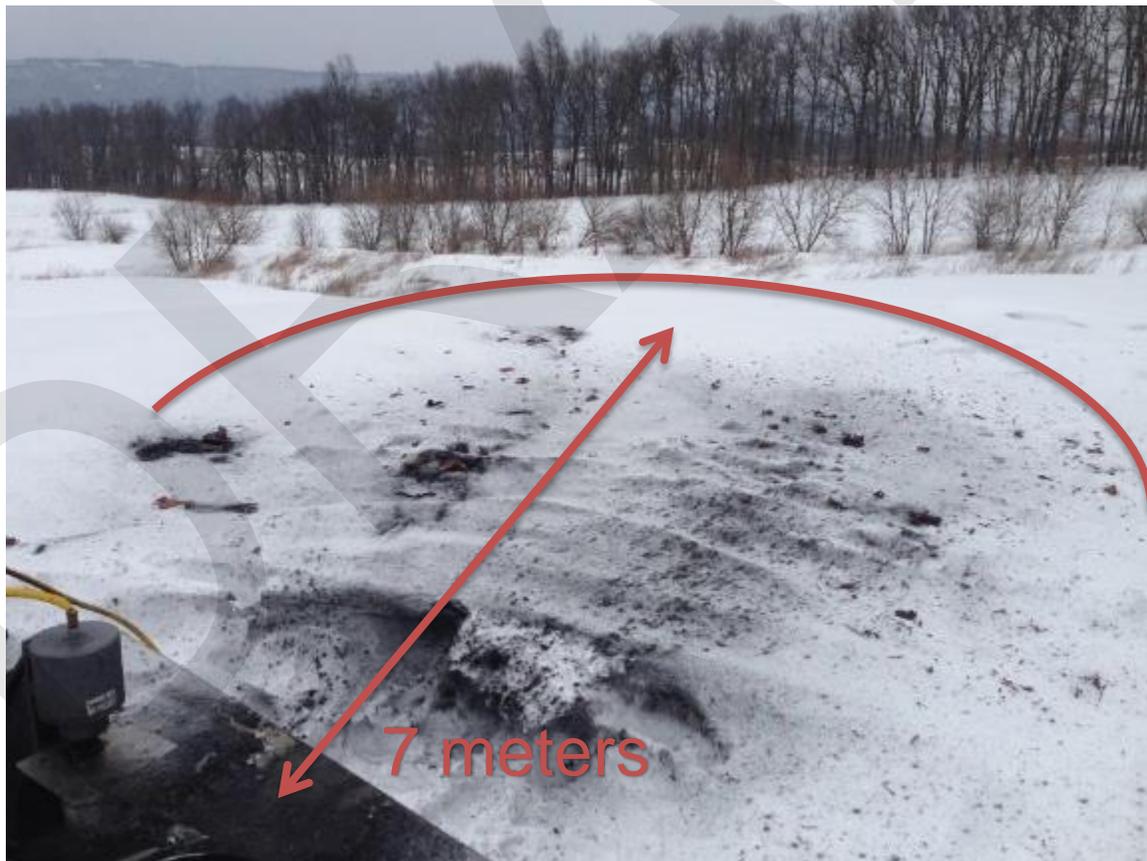
Figure 69. **Blast Radius**

As with all other tests, a fully charged 45Ah cell was installed into a test stand made of the candidate material in an overcharge event. The first attempt at a Teflon test resulted in a structural failure because the entire cell end-cap burst instead of the burst disc. Shortly after the venting event started, the end-cap came off and the force of the venting gasses projected the cap about 7 meters from the test site. Cell casings are made by welding end caps to each end of a stainless steel tube. This weld failed and as a result ejected a substantial amount of electrode material. Figure 69 shows how far this material spread from the test site.

The cell also ejected from the base and would have likely gone a great distance but hit a pile of snow, limiting its travel. This event gave the researchers an even greater respect for the power released during an event. It should be noted that each cell overcharge/nail puncture usually results in a violent venting event but the result of each event effects the cell casing slightly differently. In some cases, the burst disc fails and entire sections of the cell burst. A review of the test plan and setup was performed resulting in an increased distance between the test site and researchers/visitors.

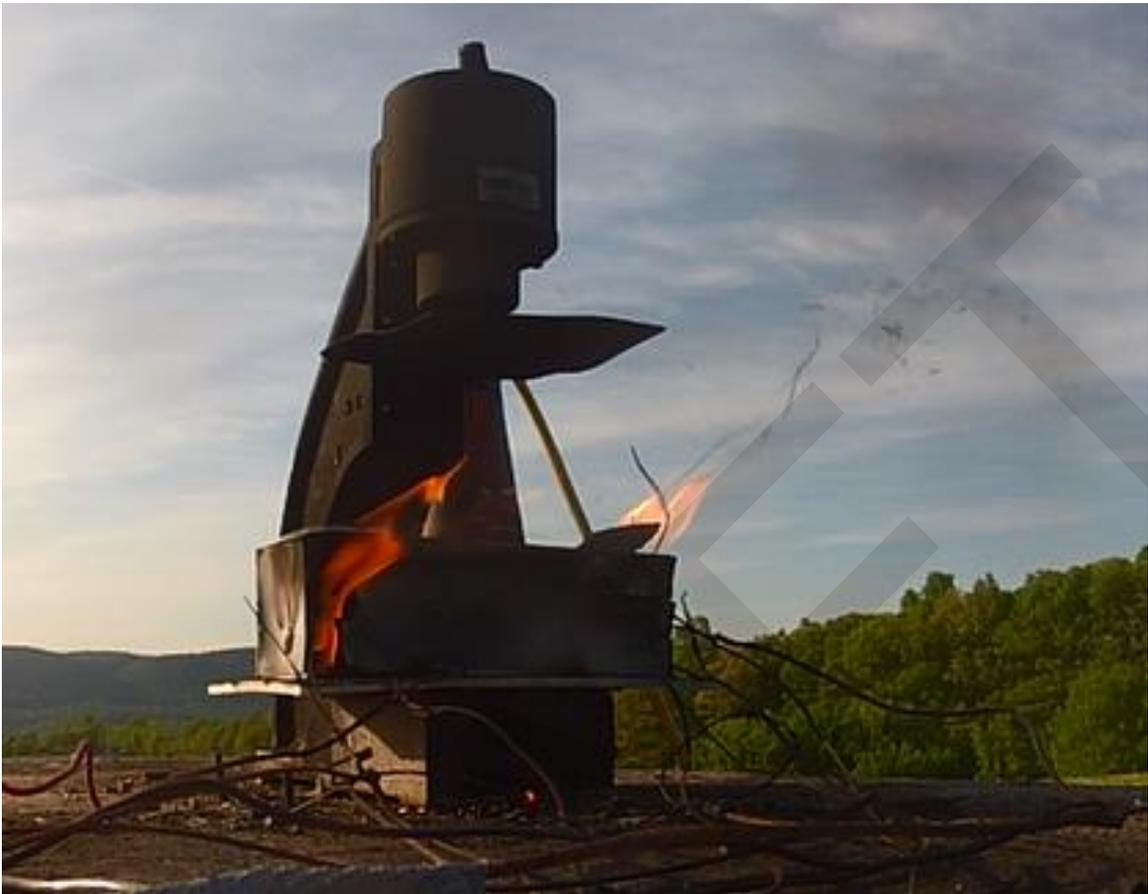
Figure 71. Teflon Overcharge Material Results

Figure 71 shows the fire resulting from the overcharge event. Note, this fire only lasted about **43 seconds**. Figure 72 shows the temperatures measured by sensors mounted to the walls of the cell enclosure made of Teflon. Note, these temperatures were only above ambient for approximately 2 minutes. This was in contrast to all other tests where high temperatures are typically sustained for at least 10 minutes. Only one signal reported a temperature above 100 °C and is likely due to hot gasses venting from the cell.

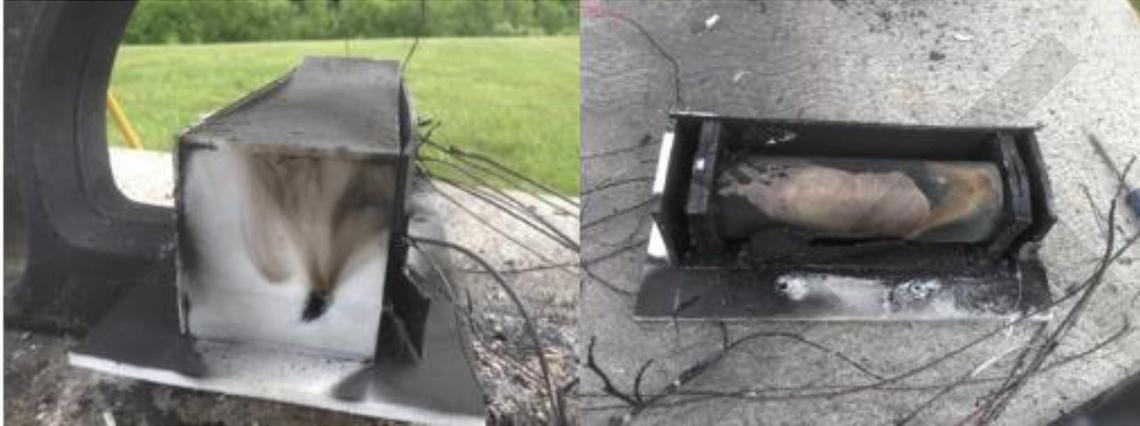
Figure 73. **Teflon Overcharge Material Results 2**

Figure 73 shows the results of the Teflon material after the cell and material cooled down to ambient.

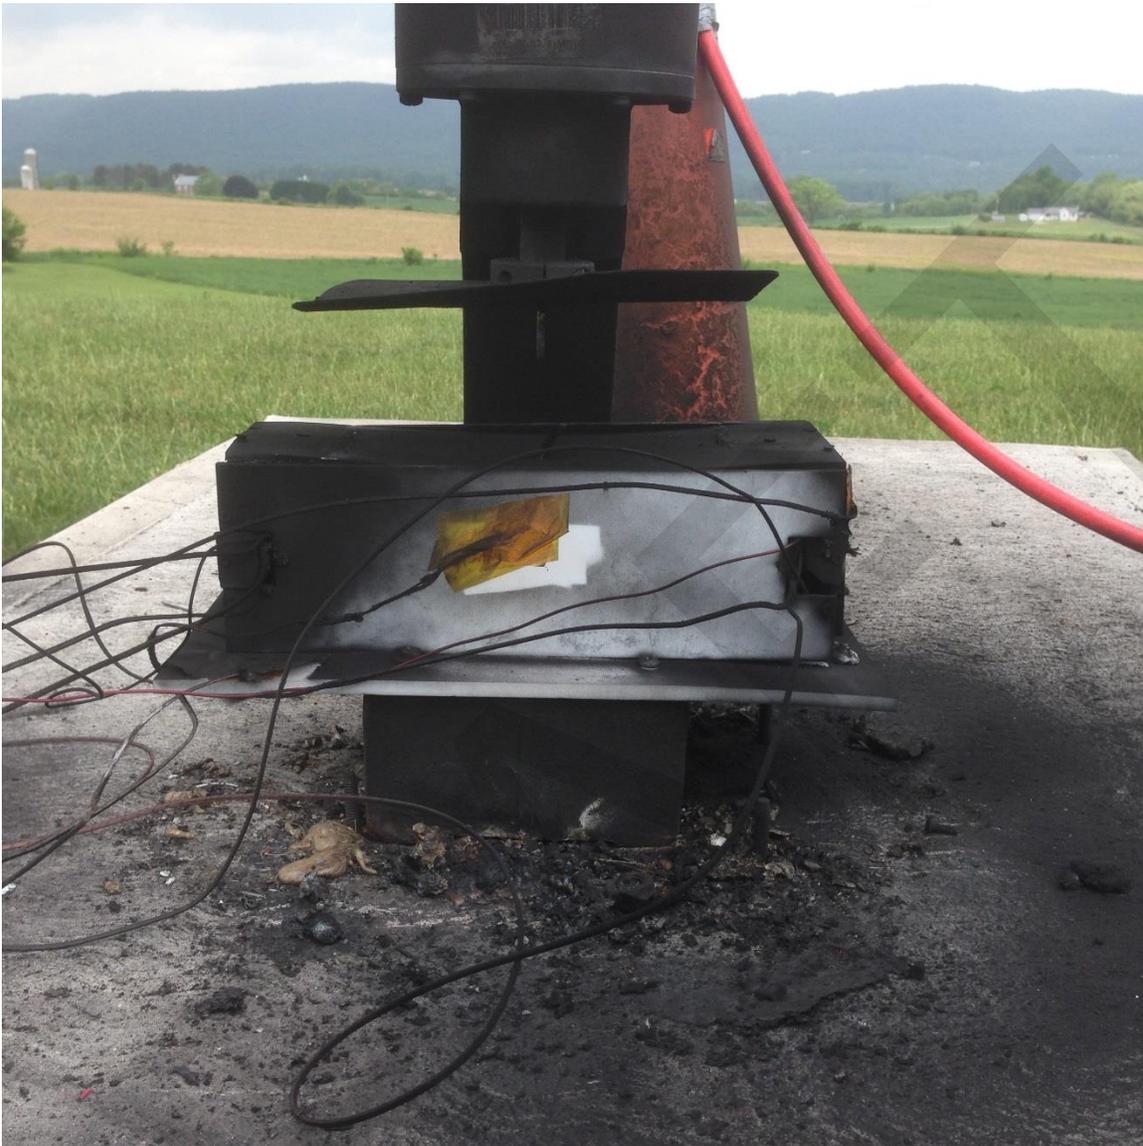
Figure 75. Teflon – Nail Puncture Material Results

Figure 75 shows the result of this nail puncture test. Note, the material is intact and shows little signs of damage, only a black coating of burned electrolyte.

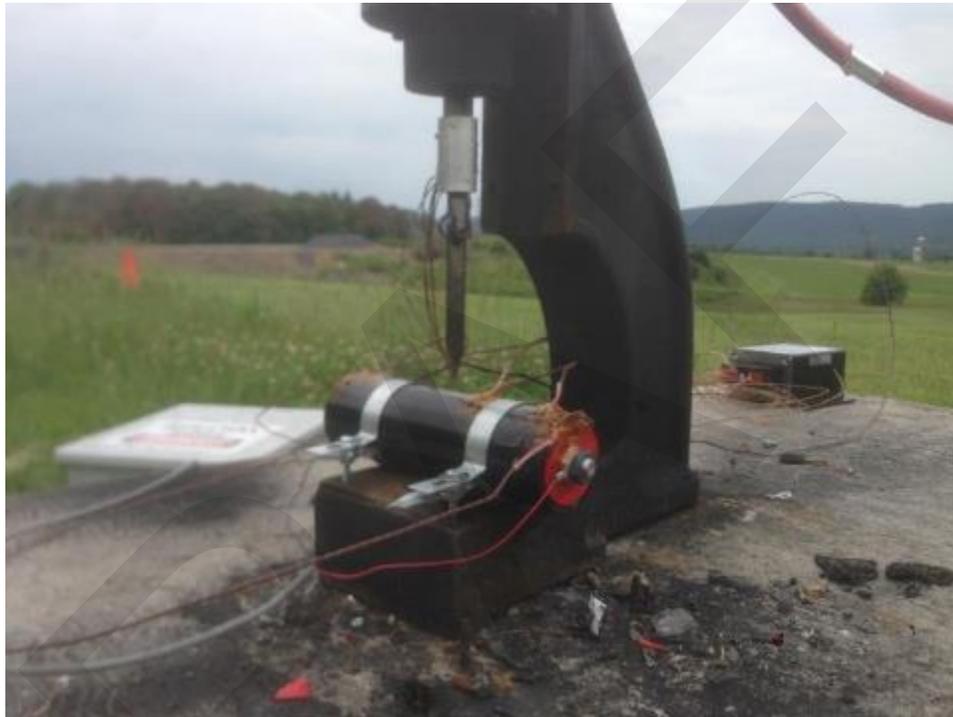
**Figure 76. Nail Tip Temperature Measurement Test Setup**

Voltage and case temperature of the cell were also recorded in addition to six temperature sensors in the nail with one of them located at the very tip.

Figure 76 shows the test setup. Notice that the nail and the cell were lined up symmetrically to get the best approximation of electrolyte temperature.

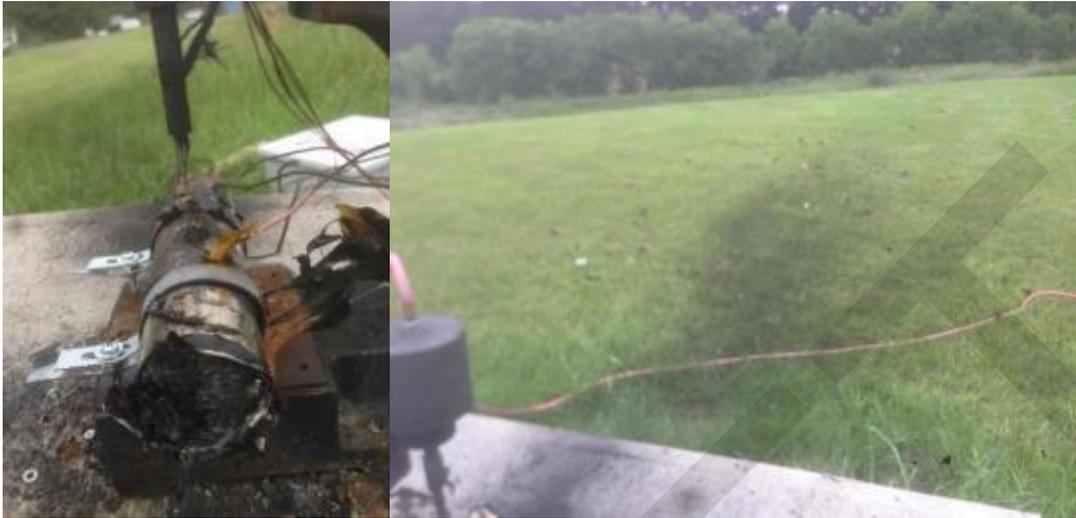
Figure 78. **Cell and Surroundings After Test**

This larger diameter instrumented nail caused a more dramatic event relative to the smaller nails used in previous testing. This indicated that the severity of the puncture and short will vary the severity of the venting event. Note, in this test the steel end-cap of the positive terminal brock off and was projected several feet as seen in the Figure 78. The left image shows the internal construction of the cell. Visible are the long strips of foil rolled into a cylindrical jelly-roll shape that compose the different layers of the cell. The same picture also shows how the nail tip broke off in the cell as the air press lifted up. The image on the right demonstrates how savage the event was because the smoke and flames marked the ground.

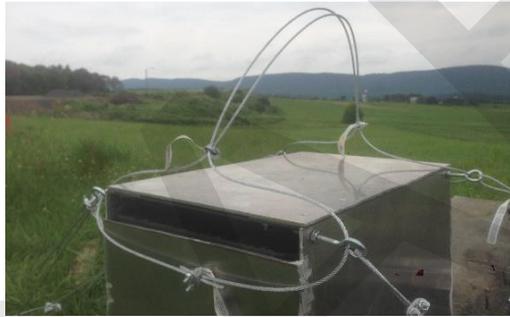
Figure 93. Handle to lift the Battery Pack up w/ the Forklift

Due to the sheer amount of energy released by the whole module, it is unsafe to leave unsecured during a destructive test. Based on prior single cell testing, it proved to this research team that tie downs to the ground were necessary to ensure the pack does not take off once cell venting occurs. The tie down system needed to be convenient to undo after completion of a test from a safe distance to avoid the potentially unsafe situation. To complete this goal tie downs were secured to the ground through a stake that could be lifted via a fork truck so as to minimize human interaction with the module. Eyebolts on each top corner of the enclosure were connected to a cable lifting loop and another cable to a ground stake as shown in Figure 93. Once the pack is forklifted up by the cables, it can be moved to a salt water bath, our storage and discharge container where used cells wait for hazardous chemical removal.

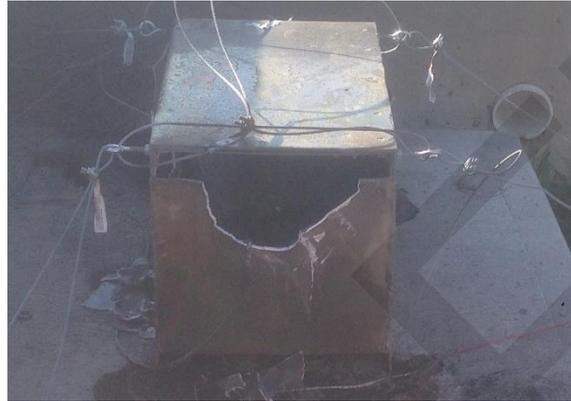
Figure 100. **Enclosure After the Test**

Once everything cooled down to ambient temperature, the cleanup procedures started. The first surprise was that the front and the back sides of the enclosures Aluminum were melted as well as the sides as the Figure 100. It was likely caused by the heat of the plastic headers burning. On the other hand, the top and bottom steel plates successfully handled the direct impact and heat exposure of the cells venting gasses.

All cells were investigated and confirmed to have vented given that all burst disks were opened. Inside the enclosure only metal parts remained. No plastic part remained. No clear sign was left that the box ever contained any plastic before.

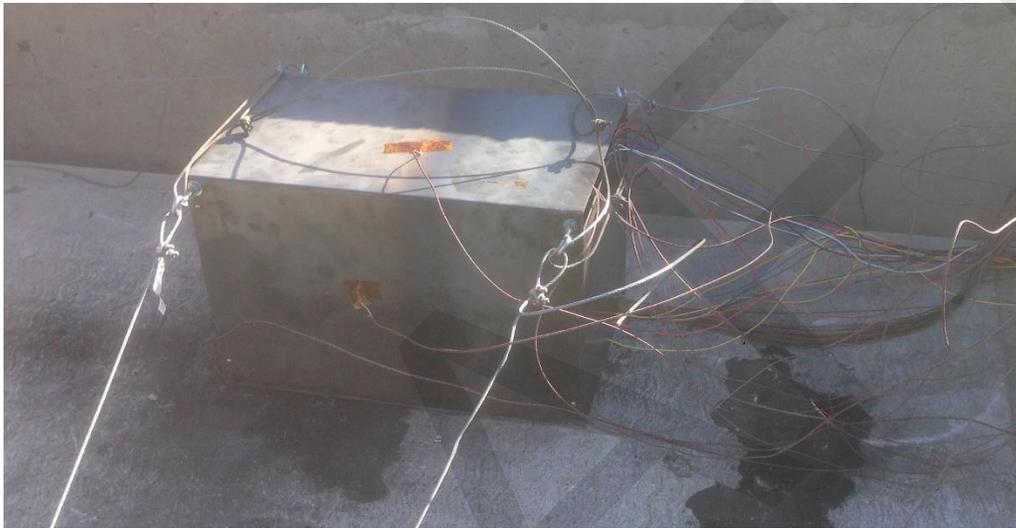
Figure 101. **Battery Pack prior to Testing**

Figure 101 shows the battery pack at the start of testing, secured down and with all the data being logged prior to initiation of charge current. The current sensor was placed at the output of the charger in the instrumentation trailer on the power cables running out to the pack on the test pad.

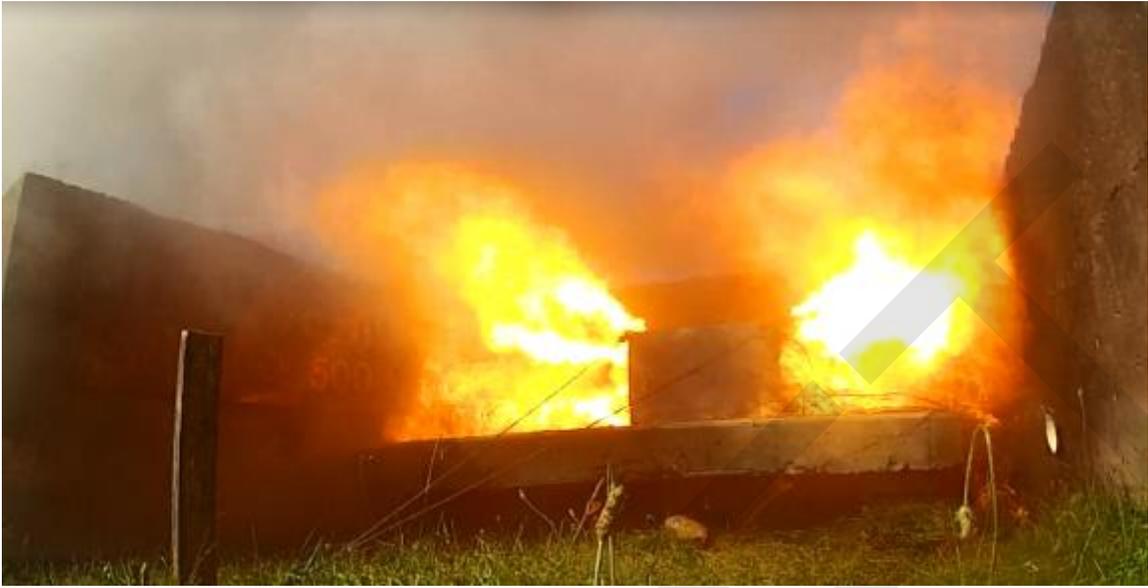
Figure 109. **Battery Pack Venting**

The Figure 109 is a screen shoot of the video recorded during the event. The picture demonstrates the brutality of the flames coming out of the openings of the pack. It wouldn't be unreasonable think that some batteries vented at the same time due to the effect of the thermal runaway propagation.

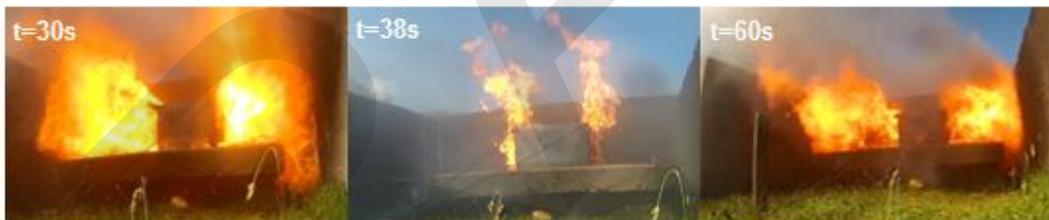
Figure 110. **Sequence of the venting process**

However, the thermal propagation was also palpable because multiple times, right after one cell had finish venting, another one started venting right away. Through the next sequence of images in the **Error! Reference source not found.**, the event is showed and explained.

On the top left of each picture there is the exact second the image was taken counting from the first cell that vented. As it has been mentioned before, the thermal propagation appeared several times and actually it did happen before the 30th second but the shots were not as clear as these ones.
