# **SAFETY OF LITHIUM NICKEL COBALT ALUMINUM OXIDE BATTERY PACKS IN TRANSIT BUS APPLICATIONS**

February 2016

## ABSTRACT

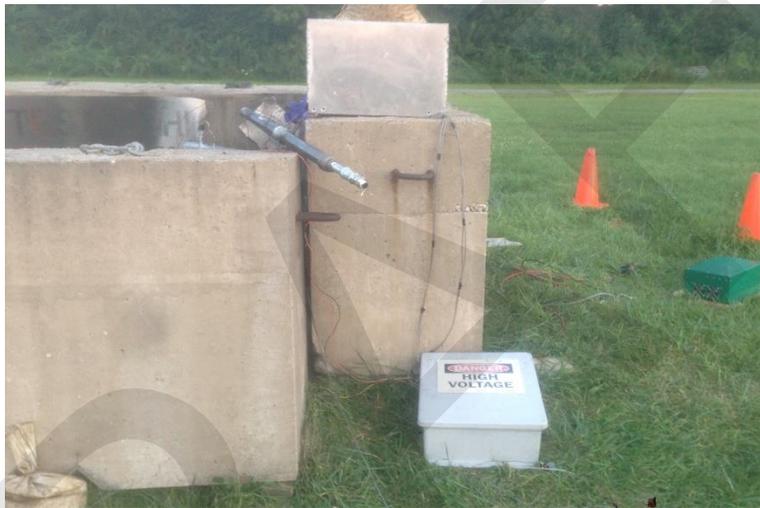
Figure 111. **Check Valve Test Exhaust After Test**

The check valve did work, but unfortunately just for a little while because too much pressure built up and the lid ended up popping up and the check valve and exhaust flew away as the next Figure 111 demonstrates.

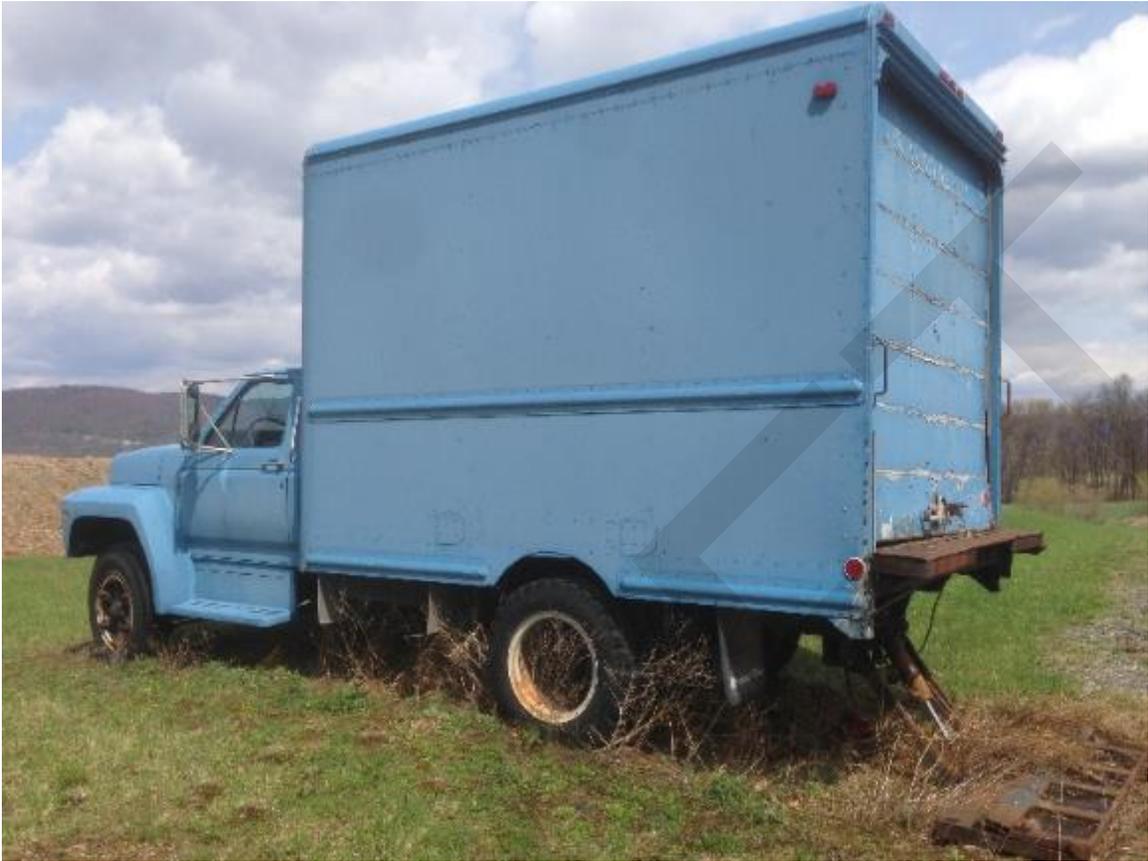
Figure 112. **18,400 lbs. GVWR Refrigerated Truck to Simulate Bus**

To simulate a small to medium transit bus, an 18,400 lb GVWR refrigerated box truck was selected from an inventory of available crash trucks at our test track. The particular truck used as shown in Figure 112 was used for on campus delivery by the Penn State Creamery and was not in running condition. This would not affect the goal of replicating the dynamics of the vehicle during an impact.

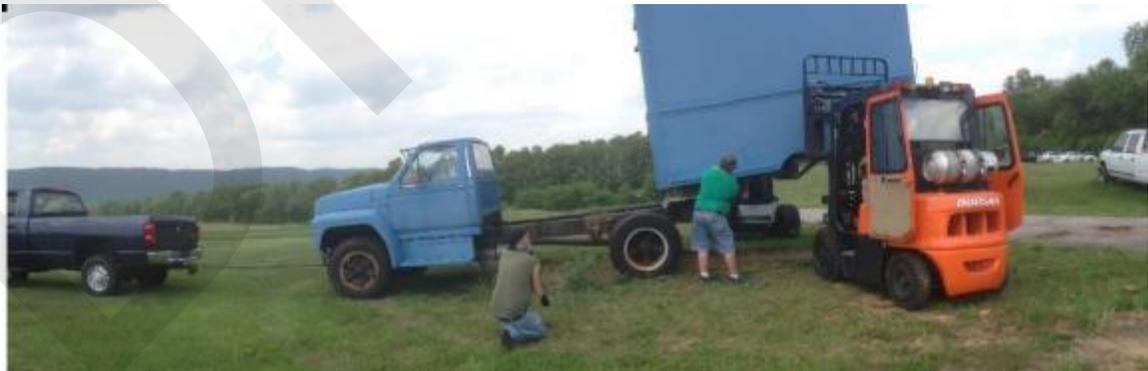
Figure 113. **Refrigerated Box Remove from Crash Truck**

The box was removed from the truck for safety reasons since if the batteries burned the bed could also catch on fire. In addition, current buses do not use similar insulated materials for their side panels so it was incompatible to test it. Using a torch, the box was cut off, lifted by two forklifts, and then the truck was pulled from underneath the box as shown in Figure 113. All liquids were removed, the tires were filled up with air, and the exhaust was cut off.

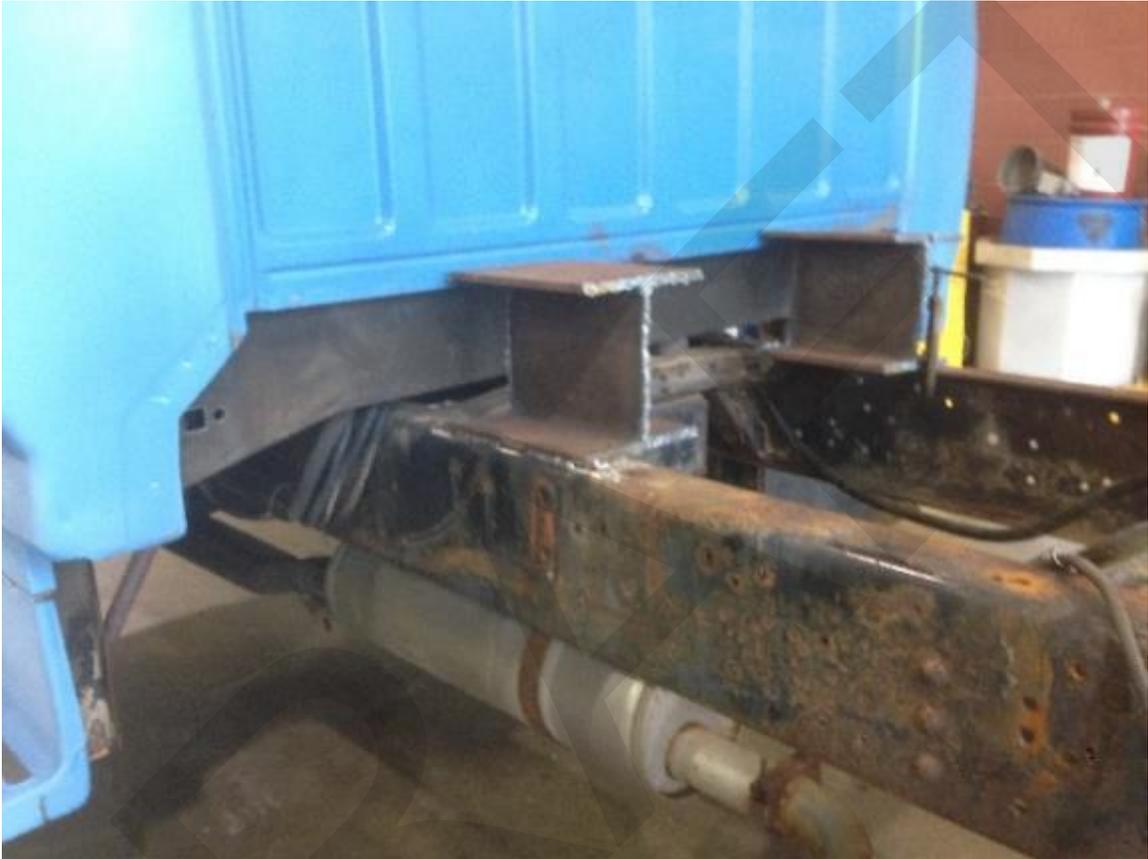
Figure 114. **I Beam Sections Welded to Chassis Frame**

The bare truck chassis weighed in at 12,250 lbs. Several options were considered to add weight and the final choice was to mount two Jersey barriers at 4,750 lbs. each mounted on I beams sections welded to the frame as shown in Figure 114 and Figure 115. Heavy ratchet straps secured the Jersey barriers.

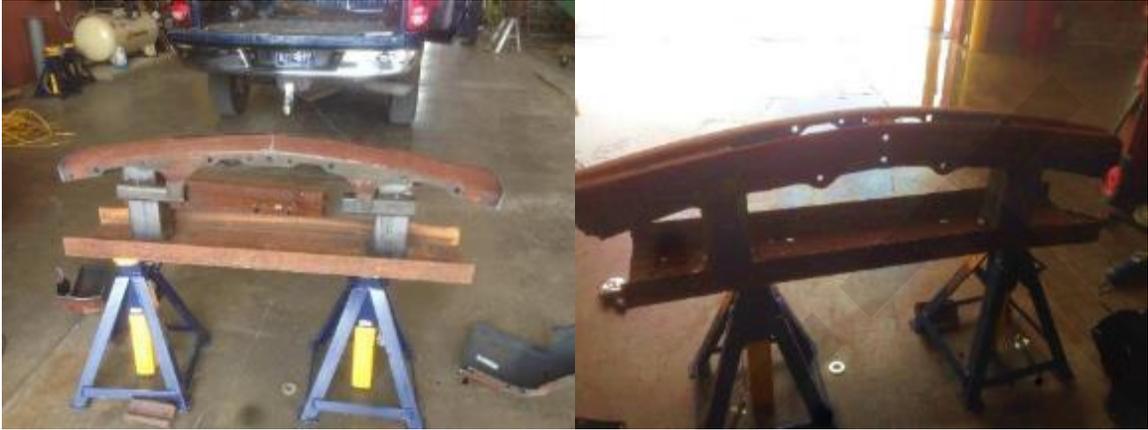
Figure 116. **Left, Top View of Bumper, Right Bottom View**

A front bumper for a 2006 Suburban was shortened to avoid a collision with the truck cab and back wheels. It was attached to the impact mass with steel tubes of similar proportions to the original Suburban frame. Figure 116 shows both square tubes were welded to a c-channel base and extra tabs were added to support the bumper from the main square frame tube similar to the vehicle design.

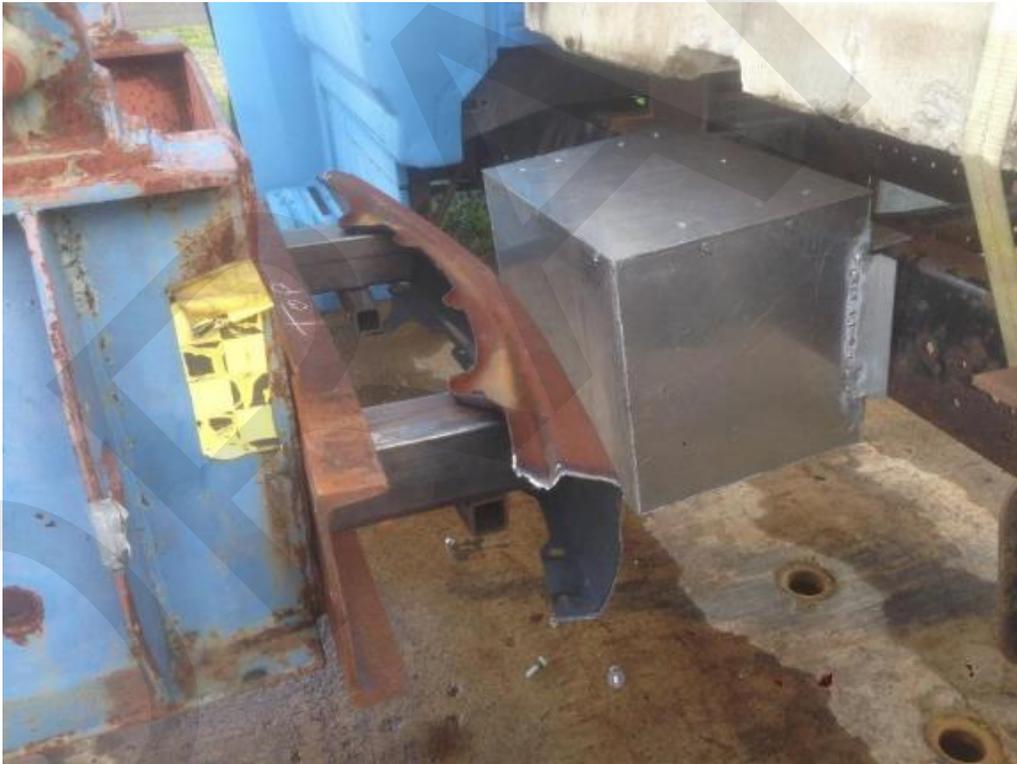
Figure 117. **Impact Mass Mounted Bumper and Battery Position**

The bumper was mounted on the impact mass and the truck aligned for direct impact on the battery module as shown in Figure 117.

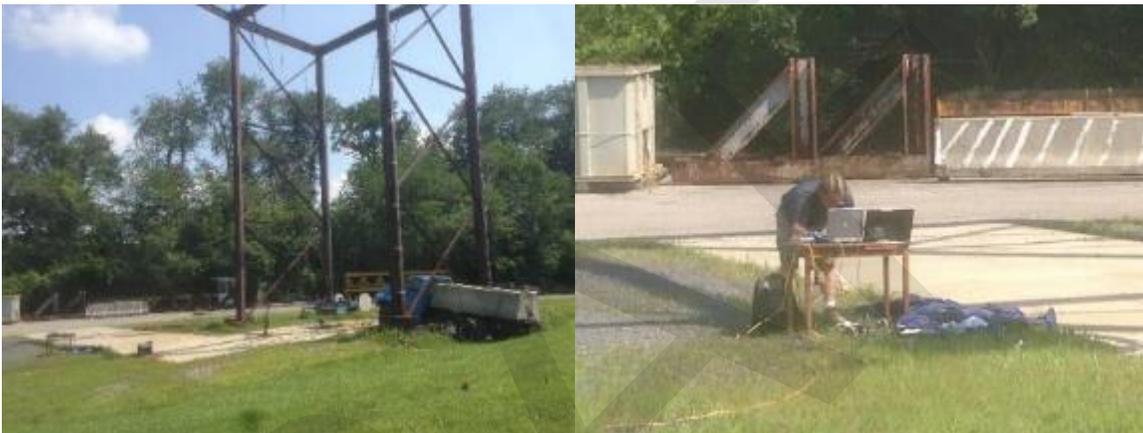
Figure 118. **Radar Alignment**

Goals of the free swing test were to insure the pendulum would impact the battery pack straight, accurately, and at the desired velocity. Exact location of the truck tires was marked on the test pad with spray paint, then the truck was moved off the test pad. Radar was set up to measure impact mass velocity. The radar is composed of two components: a laptop with software that monitors the velocity and the sensor to measure velocity of the moving mass. As Figure 118 below shows, the radar laptop was out of the pendulum trajectory while the sensor device was on the concrete test pad aligned with the approaching impact mass.

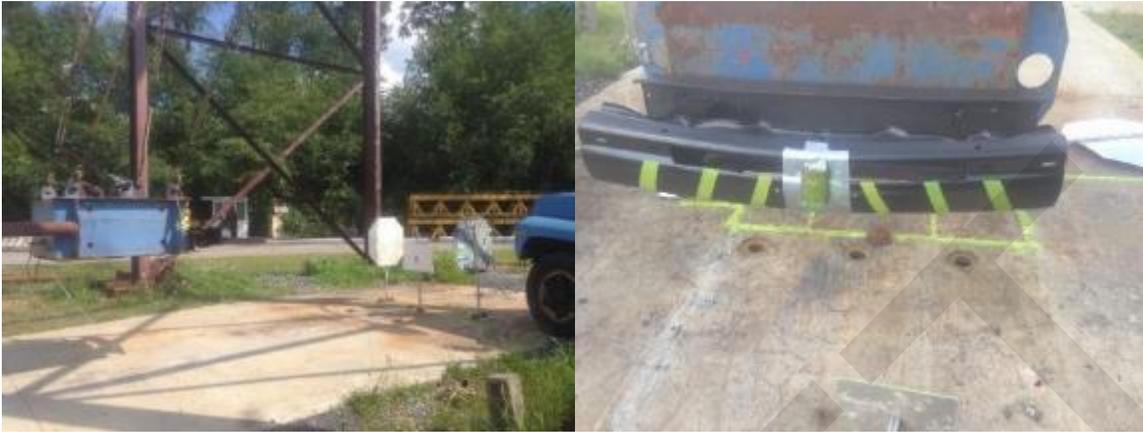
Figure 119. **Pendulum Test Swing Setup**

To determine exactly where the pendulum would impact the battery module, a sponge filled with yellow paint was attached to the bumper and a white cardboard target of the same dimensions as the battery pack was placed on the spot and height where the battery pack would be mounted on the truck as shown in Figure 119. Additional targets were placed in the positions of the truck cab and wheels to insure pendulum clearances.

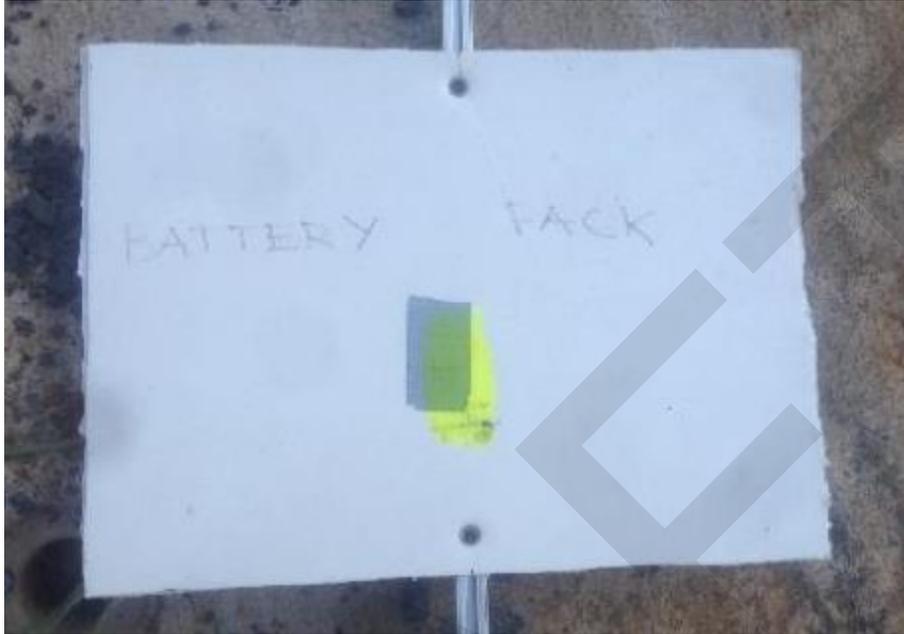
Figure 120. **Impact Accuracy of Pendulum to Battery Position**

The last free swing was also used to validate the accuracy of bumper impact location relative to the battery box position. In Figure 120 below, the yellow paint mark indicates that the bumper impacted the battery position (simulated by the gray tape) within two inches of the original alignment. The fact that the pendulum im-

pacted lower than the static alignment is likely due to cable stretching under additional dynamic loading from swing velocity.

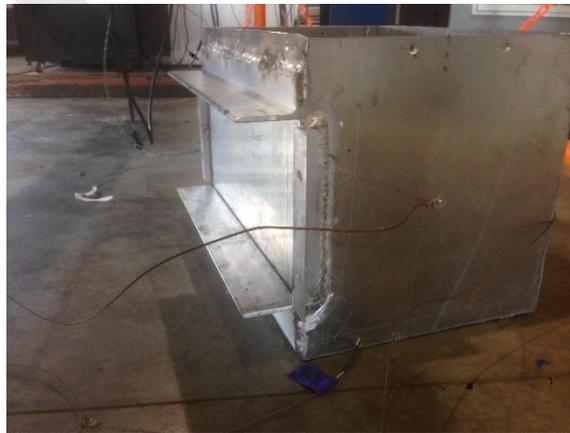
Figure 121. **Aluminum Enclosure with Frame Mounting Flanges**

The intention of this test was to simulate a full sized bus battery pack, but space limitations on the frame of the truck restricted the test to a single module with 20 cells. After making sure that all BMS and temperature data was logging properly, the pack was inserted into a steel box which was subsequently housed within an external Aluminum enclosure as shown in Figure 121. The aluminum enclosure was designed with flanges for mounting to the truck frame between the cab and rear wheels. A power connector was also attached to the pack to simulate a real pack as closely as possible.

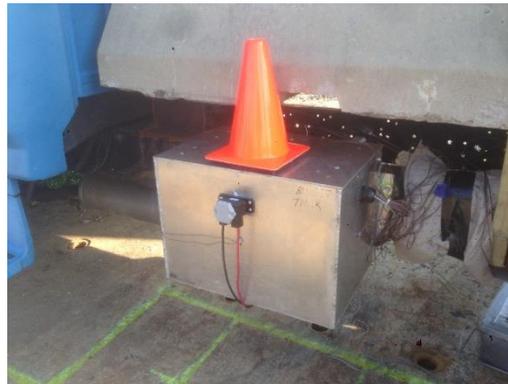
Figure 122. **Battery Module Mounted on Frame with Data Acquisition**

Figure 122 shows the battery module mounted to the truck frame between the cab and rear wheels. A thermocouple scanner was mounted to the truck frame and a data acquisition box was placed on the ground as far as cabling allowed.

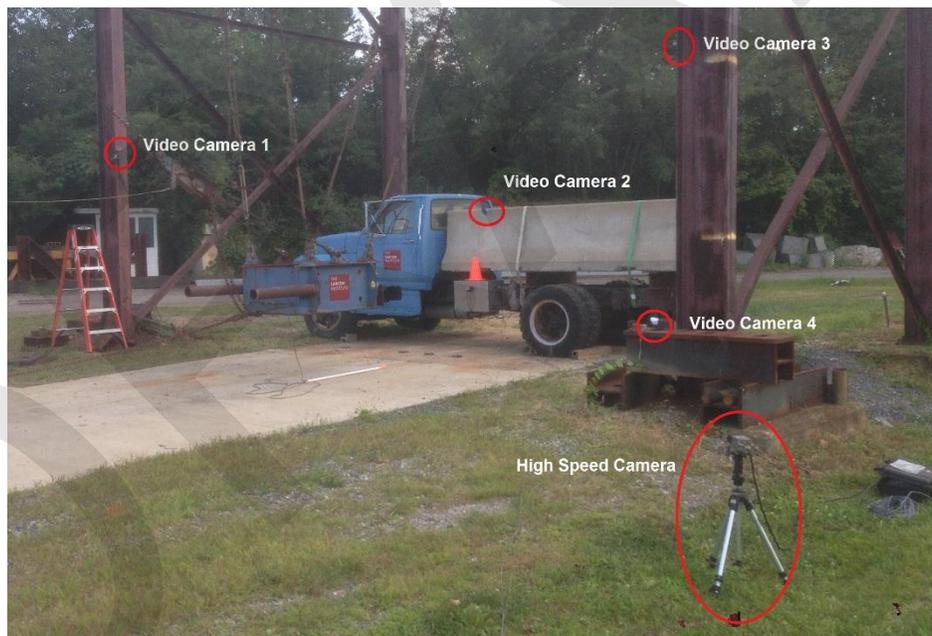
Figure 123. **Camera Layout**

Figure 123 shows the positions of video and high speed cameras placed to capture the crash event. The orange cone atop the pack is intended to serve as an inertial reference in the high speed video. The pendulum can be seen suspended a few feet away from the battery module prior to lifting.

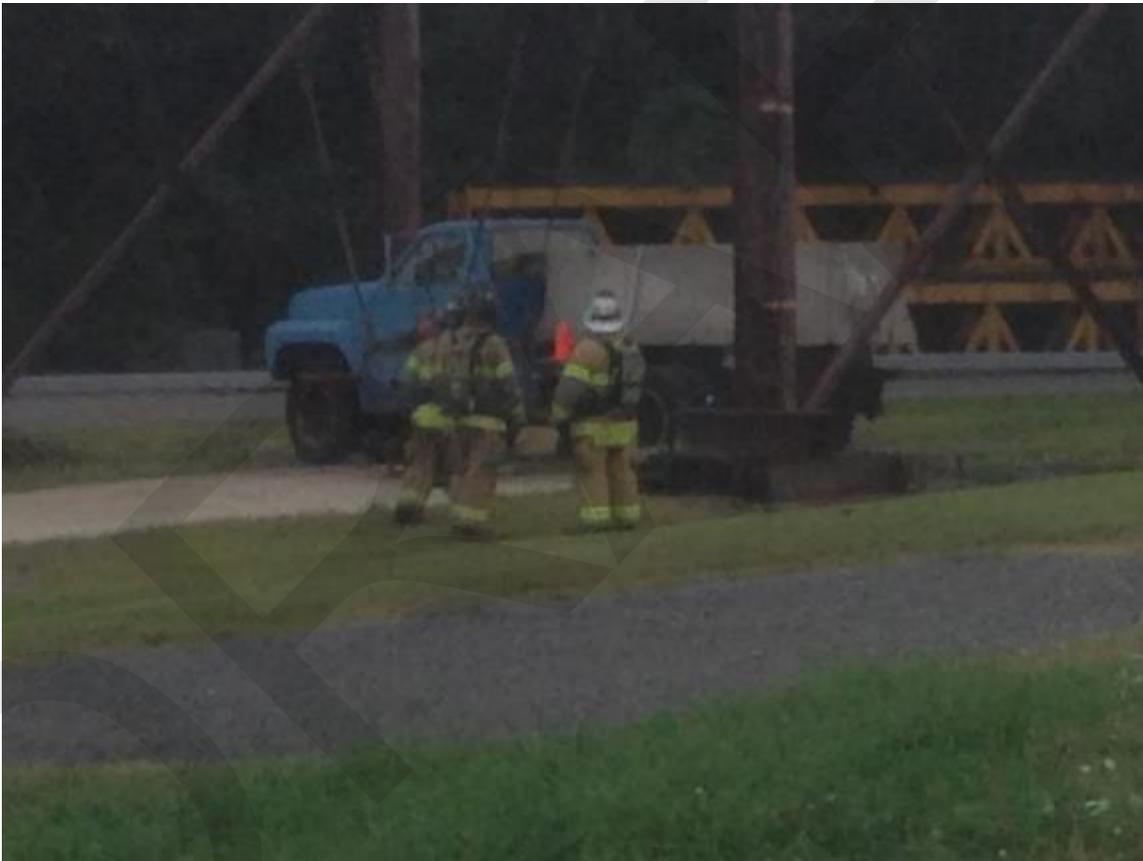
**Figure 124. Fire Fighters Approach Battery Pack after Impact**

cleared of all personnel except one observer and the tow truck driver. The pendulum was pulled up to the 25 mph lifted height of 18.92 ft. Finally, the cameras were triggered and the area was cleared of all personnel to a radius of 200 feet. A horn blast was given and the release mechanism was triggered to drop the pendulum. The pendulum impacted the box and truck which was pushed back about one foot. No venting of cells was detected upon impact. As shown in, Figure 124 local fire fighters drilled on approaching the pack in full personal protective equipment (PPE) ready to apply water coolant as would be their practice in response to an actual traffic accident involving an electrified transit bus. They also deployed an infrared camera to remotely detect hot spots on the pack, an indication of thermal runaway. No excessive heat was detected. Afterwards, the pack was left undisturbed for at least 24 hours.

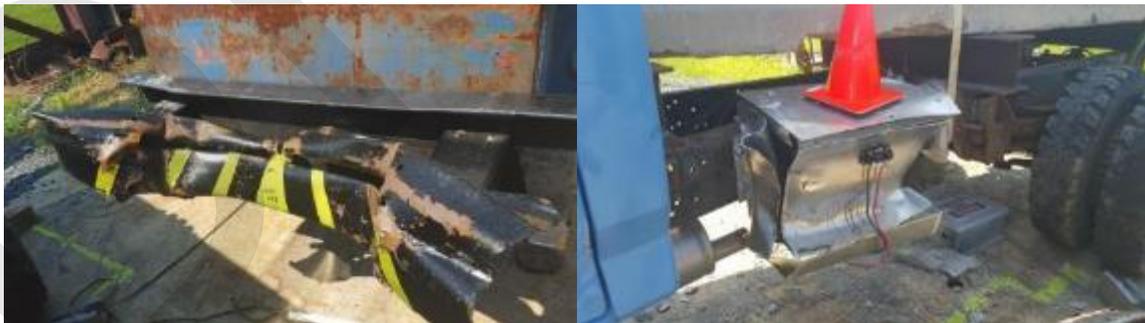
Figure 126. **Deformation of bumper and module enclosure**

Upon inspection, it was noted that the center section of bumper deformed until the simulated SUV frame impacted the truck frame on either side of the battery module. The battery enclosure was significantly dented but not totally crushed as shown in Figure 126. Some truck frame deformation was detected. The impact momentum transferred to the truck moved the front axle back 13 inches and the rear axle back 11 inches. Almost all the energy was transformed into deformation of the bumper and into movement of the truck.

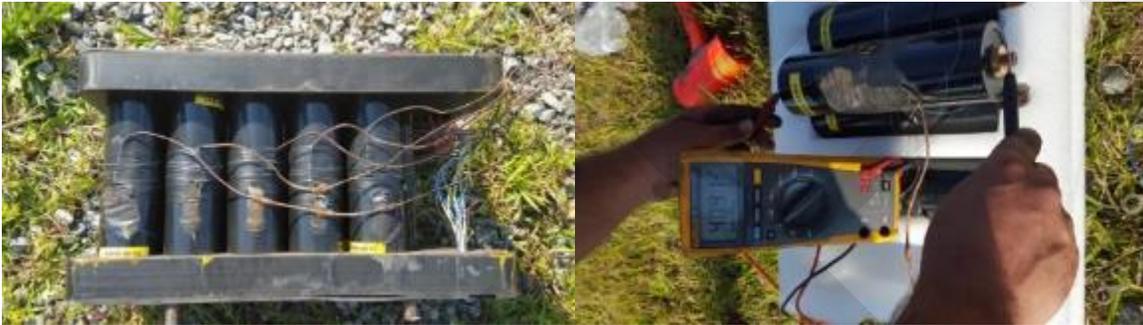
Figure 127. **Dented battery cell**

Upon disassembly of the battery pack, it was noted that none of the battery cells were severely crushed or penetrated by any part of the pendulum. In this case, all four cells on the impact side of the pack showed some abrasion and slight denting

on the outside casings as shown in Figure 127. However, this impact represents a best case scenario with the bumper and vehicle dynamics absorbing much of the energy. This would not have been the case if a more ridged component of the impacting vehicle, such as the frame, had penetrated the pack. Here, no thermal runaway occurred within 48 hours before disposal. However, these dents are severe enough to have potentially resulted in either immediate or eventual internal shorting leading to thermal runaway. Delayed thermal runaway has occurred in some high profile cases. Individual cells retained their full voltage output. All cells from this pack were placed in a salt water bath to safely discharge prior to disposal.

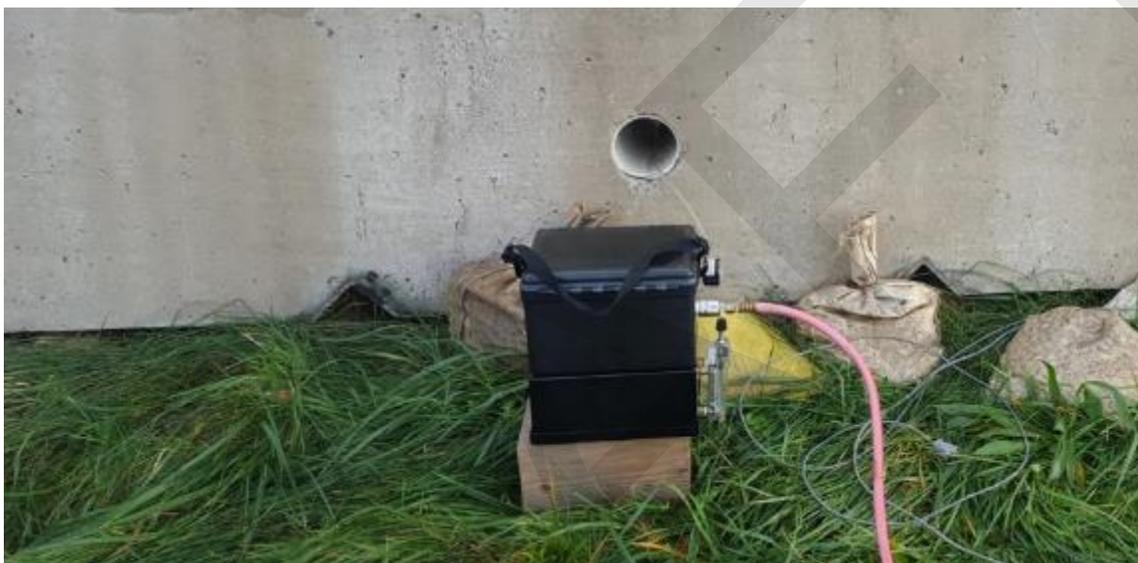
Figure 128. **Sample Tube Leading to Gas Sample Bag**

In the case where NCA batteries onboard a bus vent, it is important to understand the gases released which may present an exposure risk to bus passengers and bystanders. Figure 4 showed the types and amounts of gases released during venting, most of which were common carbon oxides and hydrocarbons including  $\text{CH}_4$ ,  $\text{CH}_2$ , ethane, propane, butane,  $\text{H}_2$ , and higher hydrocarbons C3 and C5. A validation test of gases released was run during one of our cell nail puncture tests. Sample gases were collected near the event through a tube leading to a gas collection bag as shown in Figure 128.
